DISTRICT OF HUDSON'S HOPE
SPECIAL COUNCIL MEETING AGENDA

RFD#: 2021MR31	Date: October 6, 2021
Meeting#: CM101221	Originator: Mokles Rahman
RFD TITLE: Building Envelope Assessment, Hudson's Hope Library

RE: Building Envelope Assessment, Hudson Hope Library

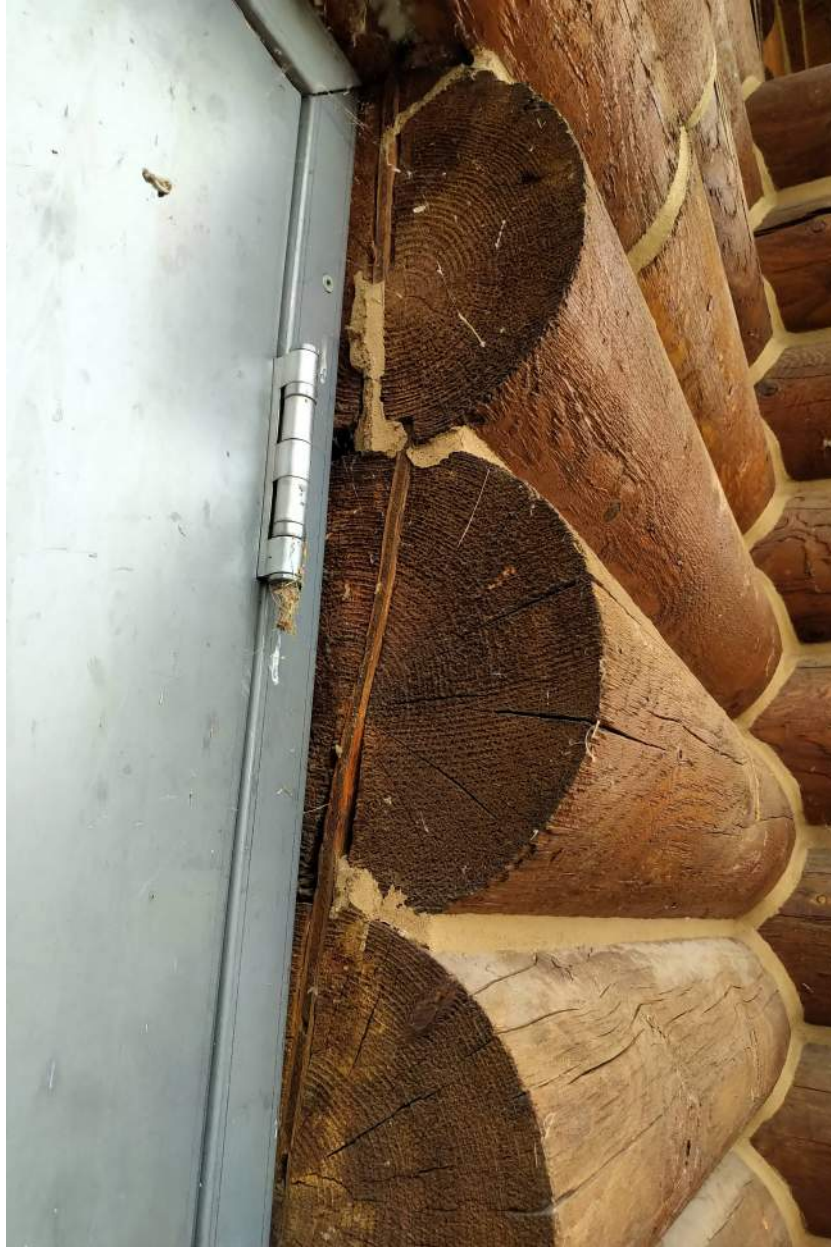
The original log framed portion of the building appears in reasonable condition for its age. Caulking and chinking between the log courses is in sound condition except for a few minor areas. Thermal insulation for the walls is provided by the log density, as well as an interior framed wall. Cracking / Shrinkage of the logs is evident in a number of areas, and is a potential source of moisture ingress. It is recommended the cracks be filled appropriately during the next log refinishing. There is some outward creep of the logs noted at one doorway, though we assume the wall was strengthened at time of door installation, as no evidence of tearing sealant or finishes in the area was noted.

Plywood Waviness indicates Prior Movement

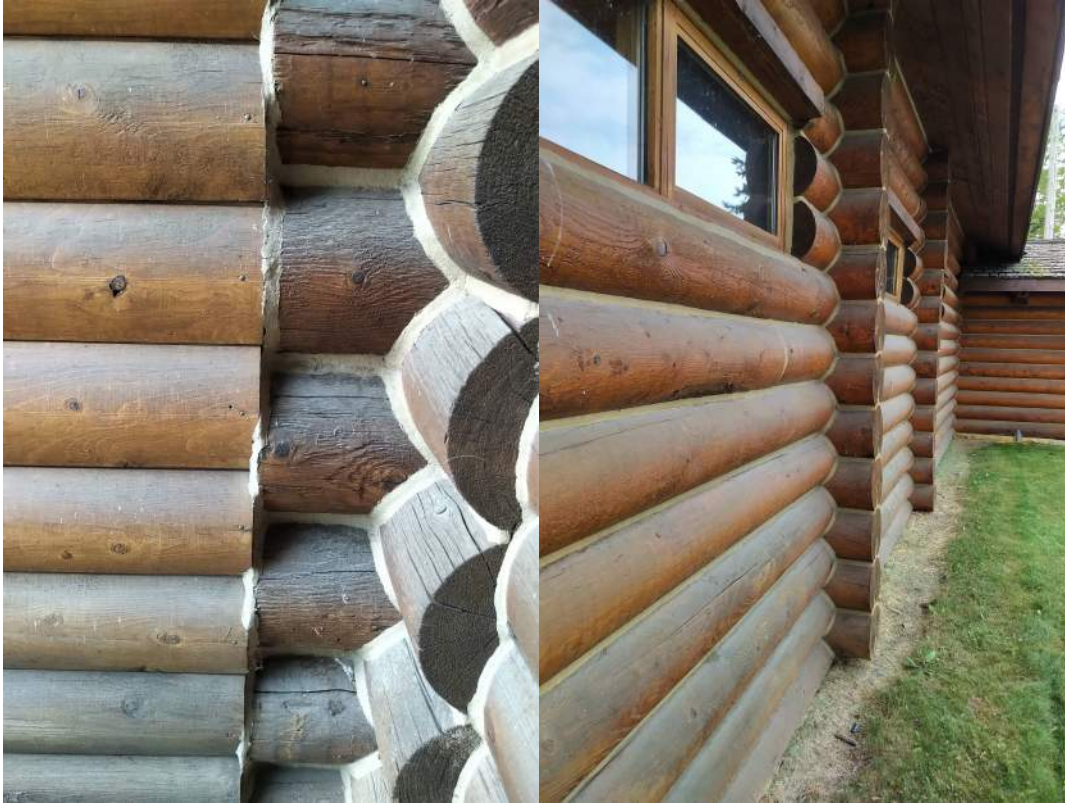
Log Chinking / Sealant Details

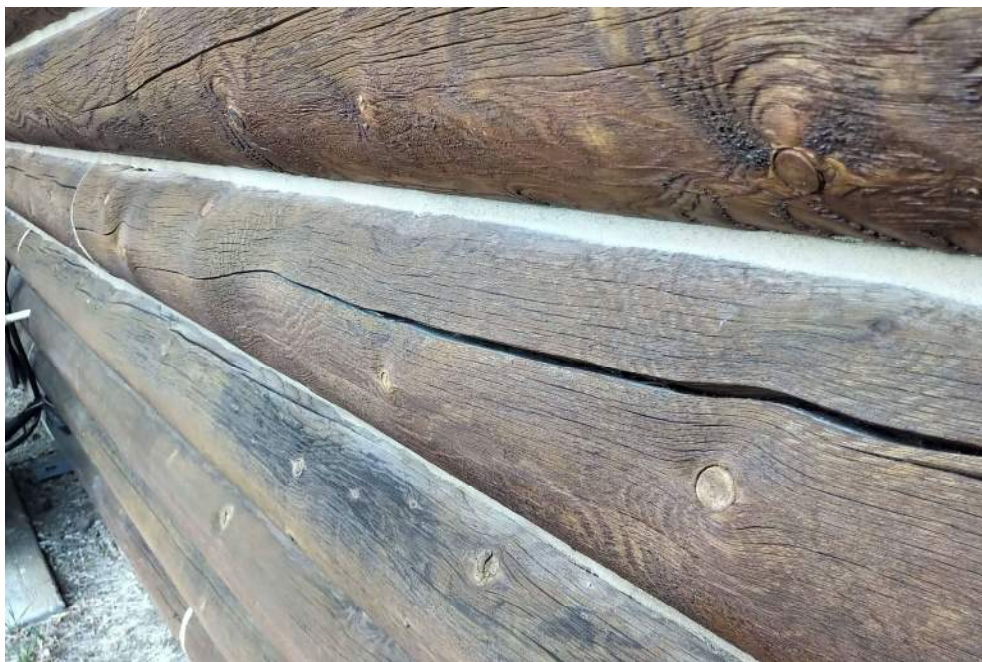
Significant Checking / Cracking of Log Due to Shrinkage

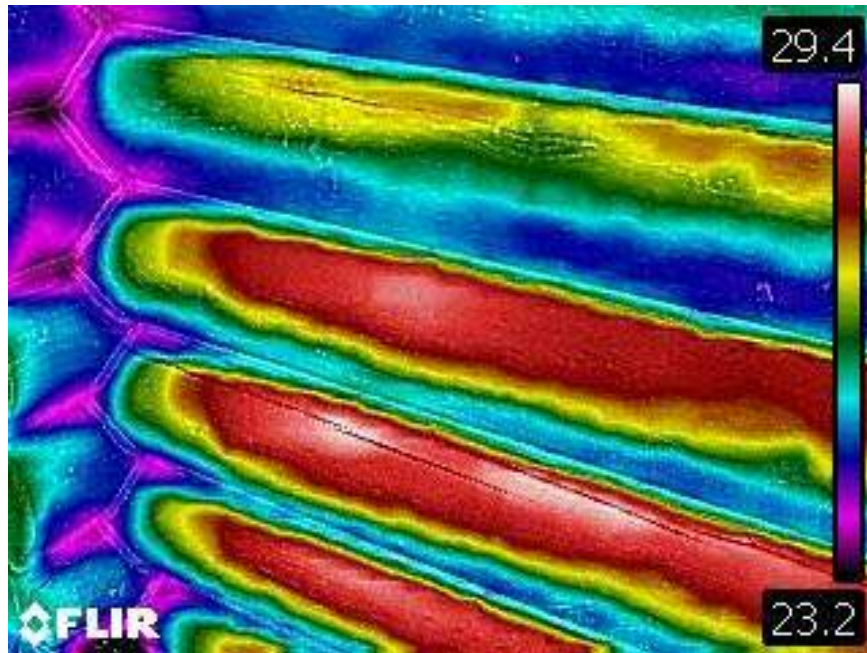
Thermal efficiency is as expected, reduced R-values are experienced where the wood timber cross section area is reduced at joints between courses. This is an inherent flaw in log building design. Any products used to refinish logs need to be carefully reviewed to ensure they can resist external wetting and sun deterioration, yet provide vapour diffusion from the logs

Variation in Emissivity due to Log Thickness

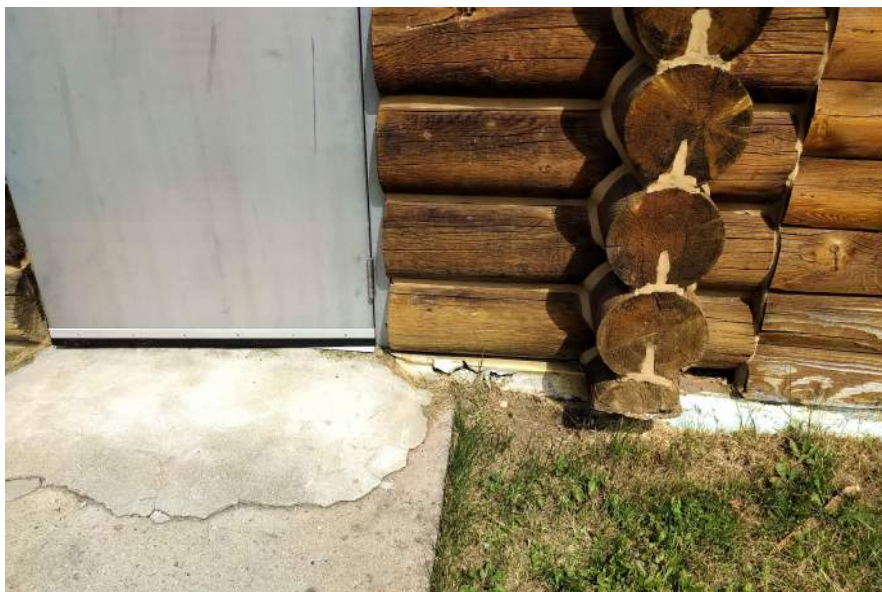
Sounding of the logs did not indicate significant decay in the log courses, save of the base course on the south wall, at the interface between the Reading Room and the South Exit Door. This course had a notable change in tone when struck, indicating appreciable decay.

Decayed Log Base Coursed, Right of Doorway

Of further note, when struck, an eruption of ants emerged from the wood, indicating infestation. Staff reports that ants are a frequent nuisance at their desk along the same south wall. During our roof inspection, we further noted ants on the logs as high as the gable framing. Fumigation, including exterior soil treatments is recommended to be performed immediately to limit damage, as well as landscape controls to be discussed in a subsequent paragraph.

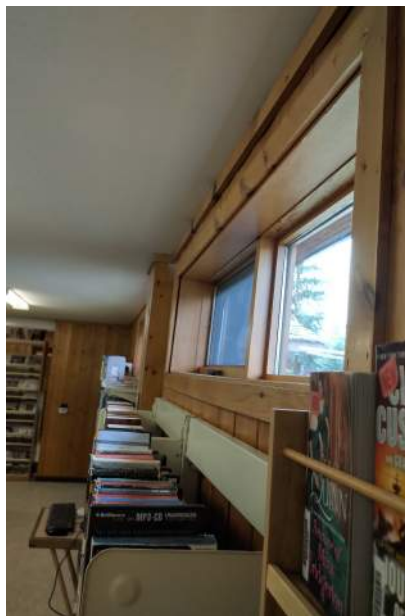
First Addition, Uses original 1974 Windows Relocated

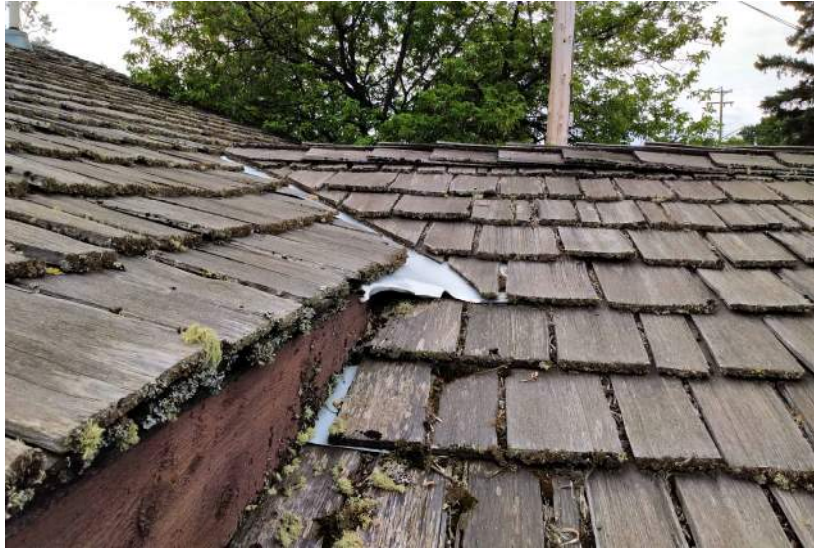
The roof of the original log building appears to be the original wood shake roof. The shakes have well exceeded their anticipated lifespan, and are in a near failure state with evidence of valley repairs having been conducted previously. Tree growth and branch wear is also shown on the vestibule, and it's recommended the tree be professionally pruned or removed altogether.

Valley Flashing at Entry Vestibule

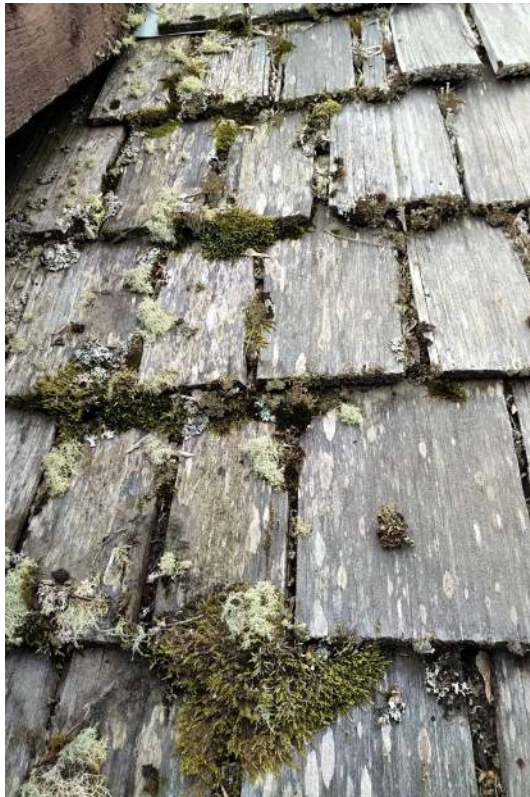
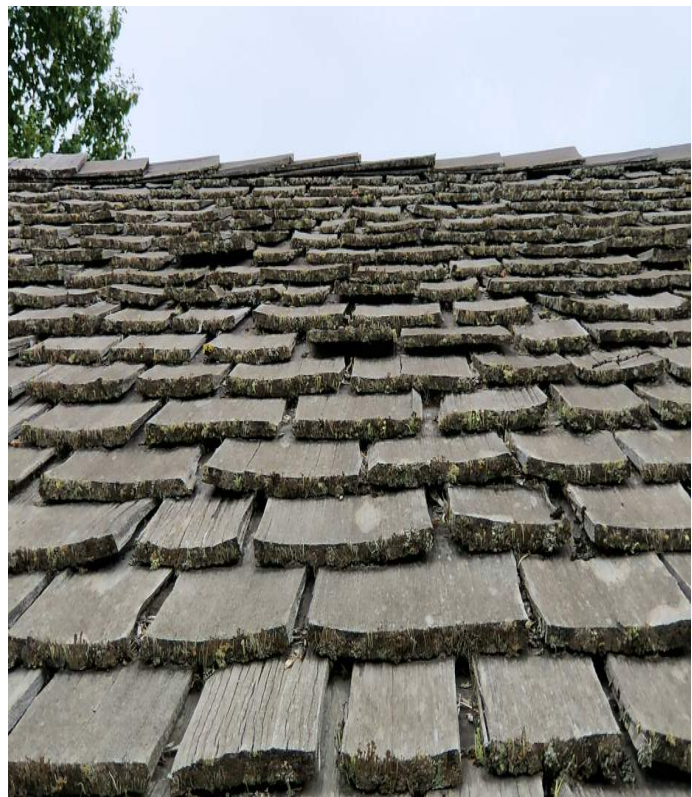
Moss Covered and Brittle Original Wood Shakes

Our conclusion is that the complete building roof membrane is a loss and at risk of failure, and replacement should be scheduled as soon as possible. Recommended roof to maintain the aesthetic is the Decra Shake or Shake XD metal stamped wood shake (<https://www.decra.com>) , or Vic West equivalent. A metal roof should significantly extend the lifespan of the roof, and will reduce underwriter risk assessments versus a real shake roof.

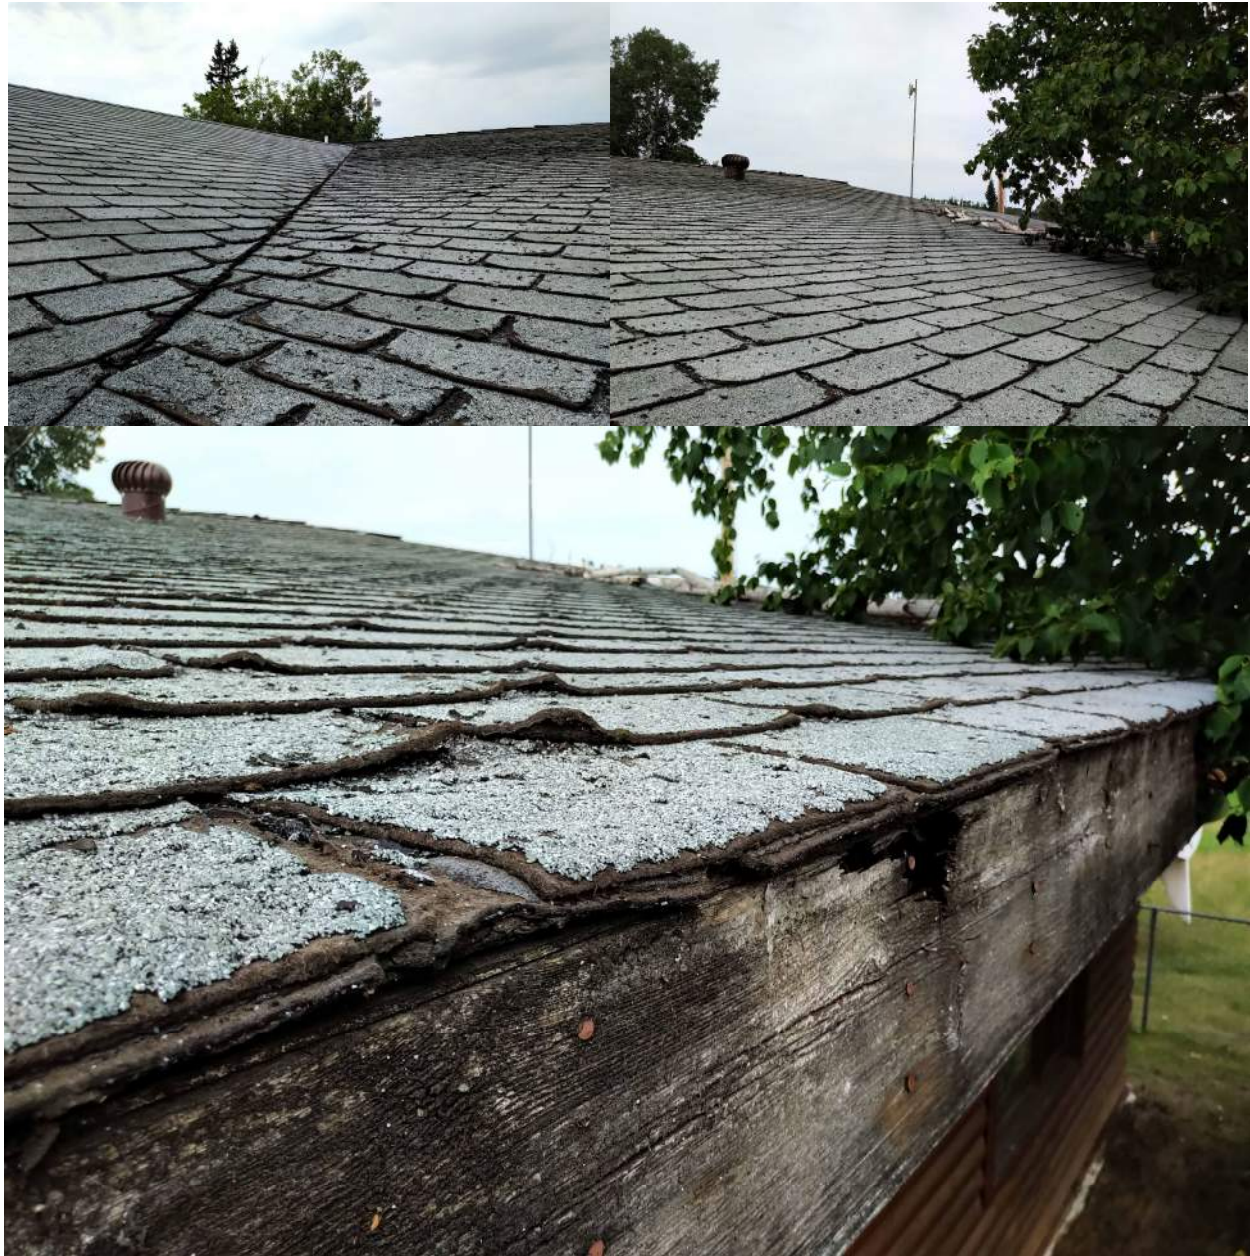
Only the westerly exposed roof appears original. The eastern, or river side roof, is an asphalt shingle, replacing the original shake roof at the time the Reading Room addition construction. At their current age, these shingles have also now exceeded their anticipated 25 year lifespan,

and show signs of granule loss, cupping and curving of the asphalt tabs, and wear/abrasion from overhanging trees. Drainage is obstructed by branches, and more tree pruning/removal is required.

General Asphalt Roof Condition

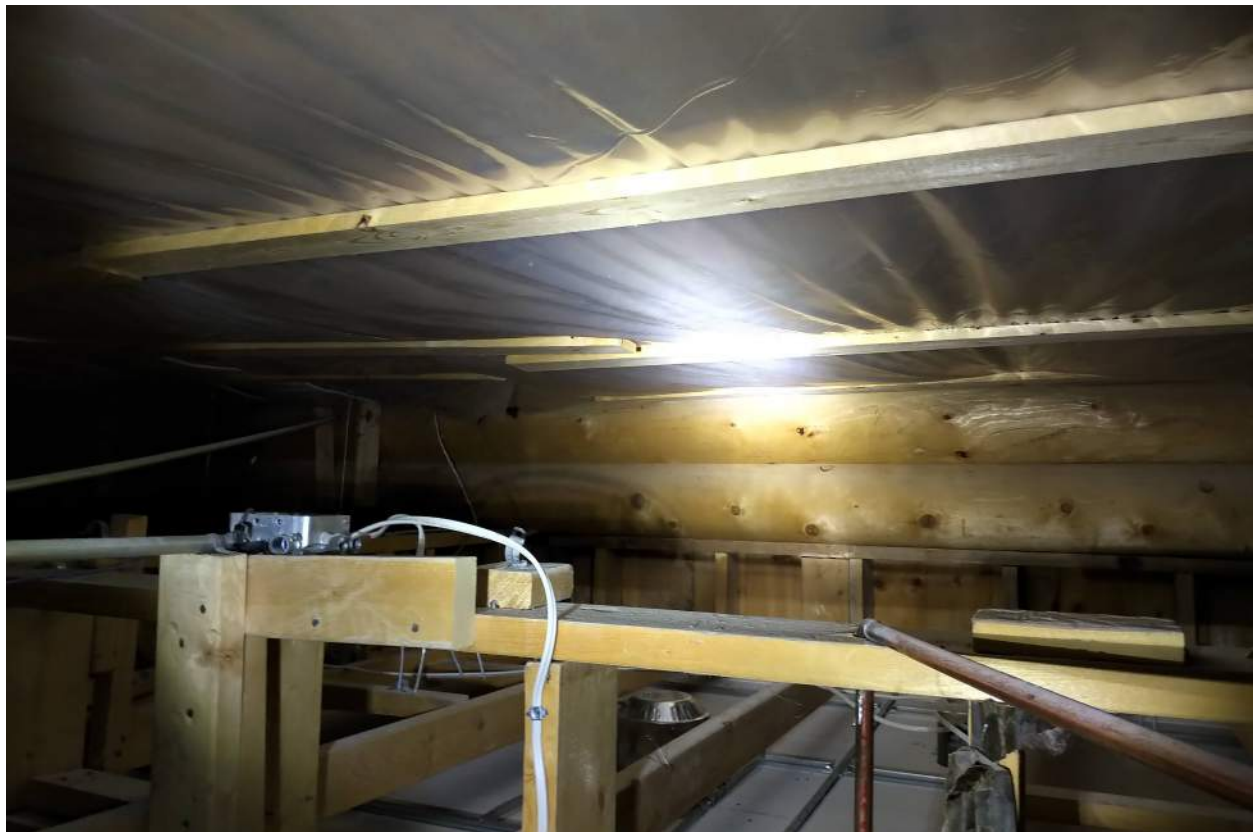
Roof insulation is a fiberglass batt/blown material, held in place between joists with only the vapour barrier. Sealing of the vapour barrier appears to have been well executed, but if more insulation is contemplated to be added in the future, a proper structure will be needed to retain the added weight. Staff at the library did not advise that ice dams, icicles or other signs of poor insulation were experienced at the site, thus we infer that the insulation level is appropriate for the level of heating. Re-roofing should carefully consider and ensure attic ventilation is not diminished, and should be brought to modern levels to ensure continued performance.

Insulation and Vapour Barrier above False Ceilings.

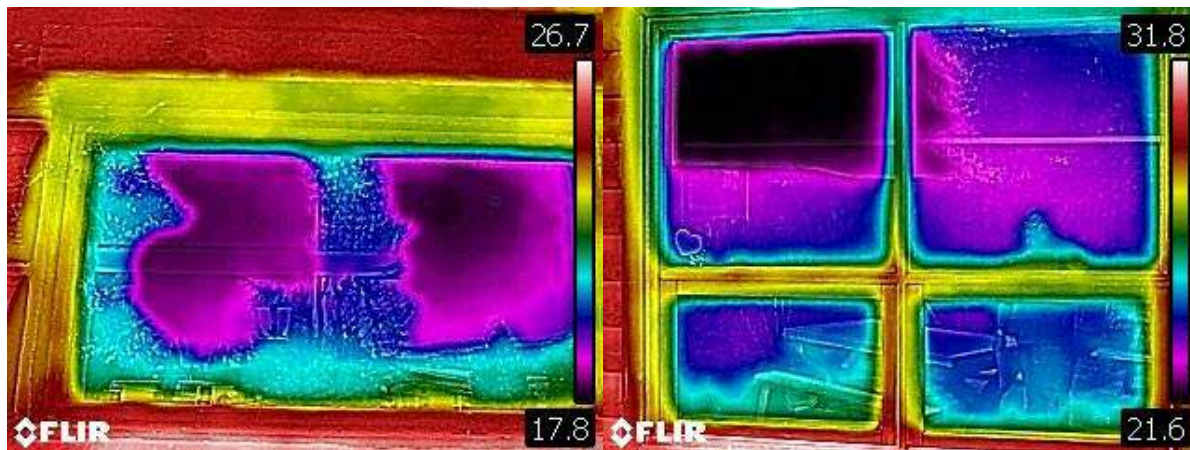
The thermal efficiency of the windows is on average for modern replacements. While modern windows can increase the thermal resistance of the assembly through the use of triple pane, low-E, argon filled, and heat mirror films, in practical sense the best available window typically only results in a window in the R5-R8 range. Often any improvement in the window is often negated if the window opens, as leakage past seals reduces overall efficiency.

Window Thermal Imaging
Original 1974 Window (Left) 1994 Reading Room (Right)

We did not observe any obvious defects, and staff did not indicate any excess condensation between panes to indicate glazing failure. Work is needed in exterior stain / maintenance, and we understand all windows are schedule for near term replacement.

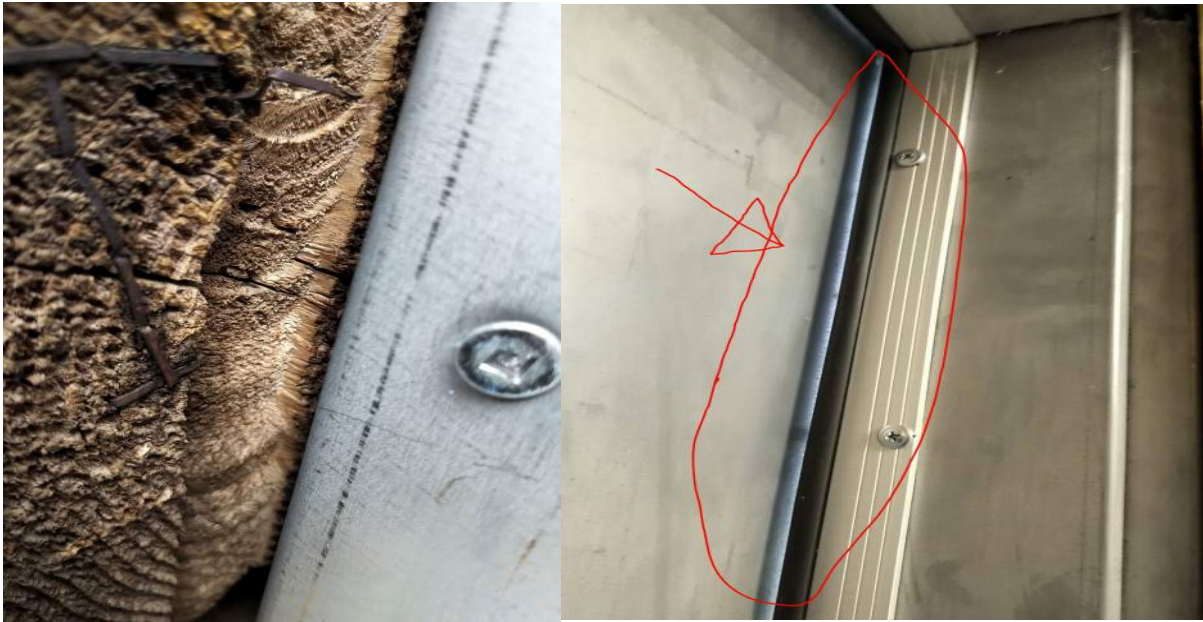
Exterior Doors to the facility are largely new replacements. The newer three steel doors exist as emergency exit doors, two on the north wall, and one on the south wall. All three were found not to be fully installed to correct standards and are a significant air leakage source. Issues ranged from gaps in framing to flashing, and included lack of final adjustments to make the doors close properly and adjustment of sills and seals. Poor installation is contributing to a large energy loss, as evidenced by the daylight we could observe between gaps. Additionally,

No Exterior Caulking (Left) Massive Seal Gaps (Right)

the doors only have the light galvanized factory finish, and have not been painted. Final adjustments should only be done after painting/finishing of the doors.

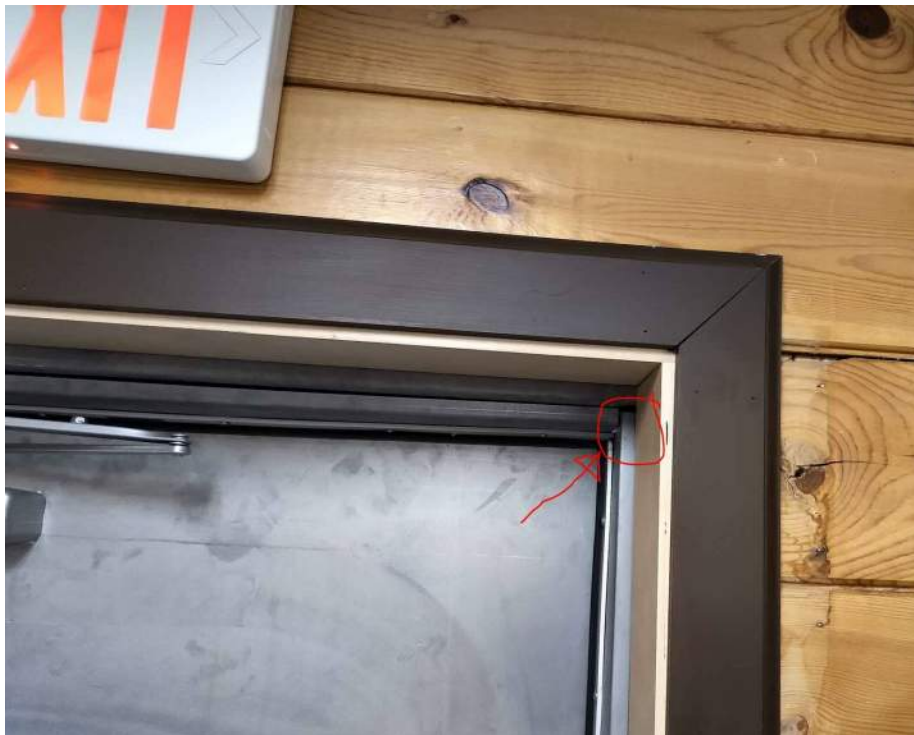
Daylight Showing Through Frame Components due to Improper Assembly

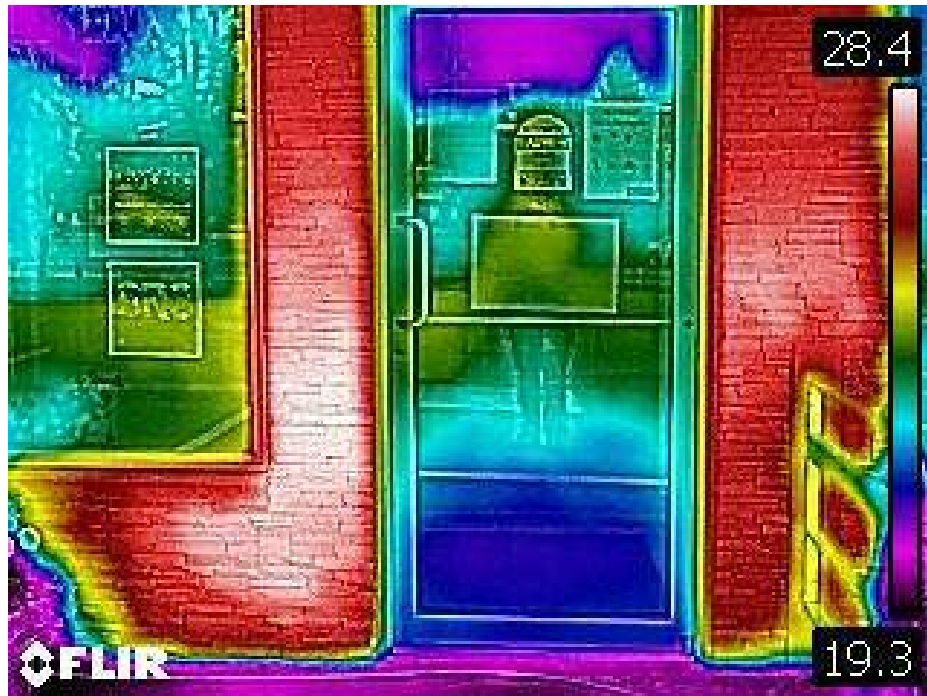
Entrance glazing and doors have been retrofitted for barrier free operation and are of a standard typical of the era of when they were constructed. We could not verify the thermal break in the mullions or door. Staff did not report any heaving, or heavy frost build up on doors during our review.

Entrance Door Thermograph

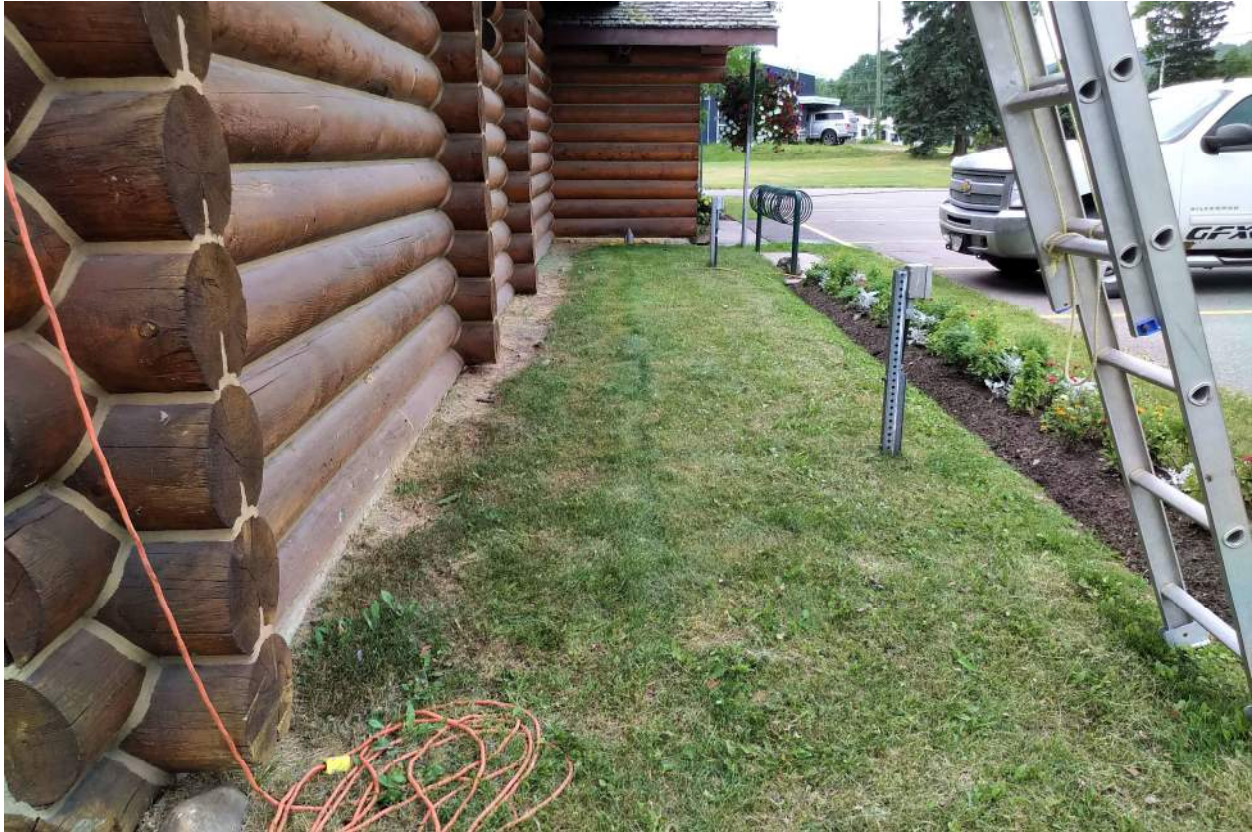
The library site is atop the river embankment, and as such, overall site drainage is good. Maturity of landscaping has reduced the vertical offset between wood framing and grade to almost zero in many instances, and as such some remedial work is required. The BC building Code requires earth to be a minimum of 6" (150mm) below any untreated wood element. We recommend regrading around the perimeter where this minimum is not met to also involve sloping the grade away from the building a minimum of 2% for the maximum practical distance, and incorporating swales if necessary. Offsetting the grade to the required minimum should also reduce, after fumigation, the tendency for insects (ants) to inhabit the wood elements.

Grade Proximity to Wood and Minimal Slope at Front Elevation

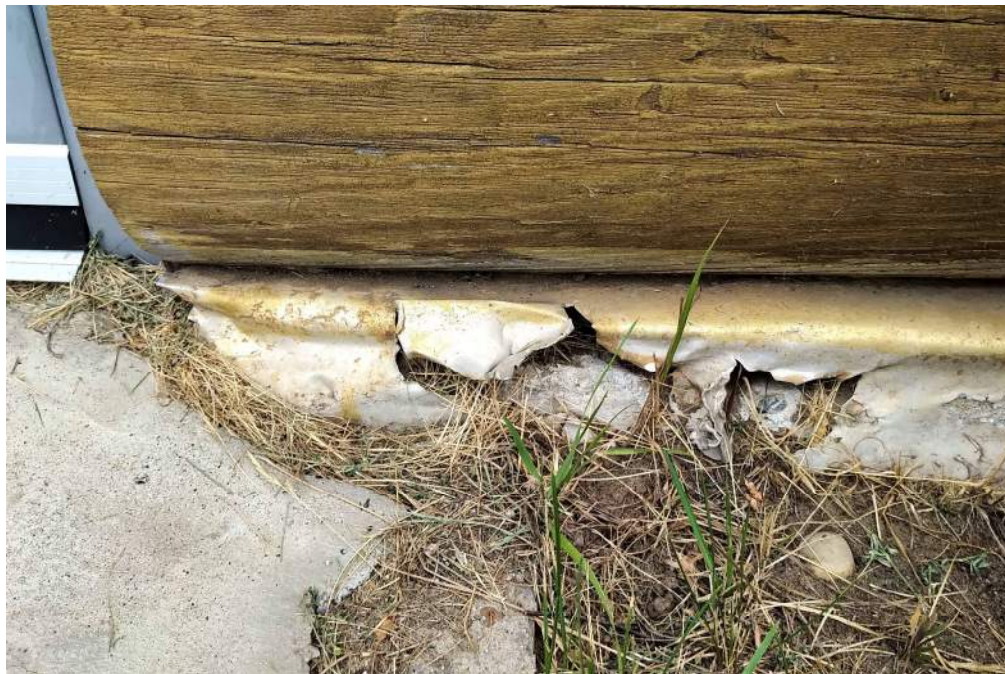
Grade Level, Damaged Flashing, South Emergency Exit.

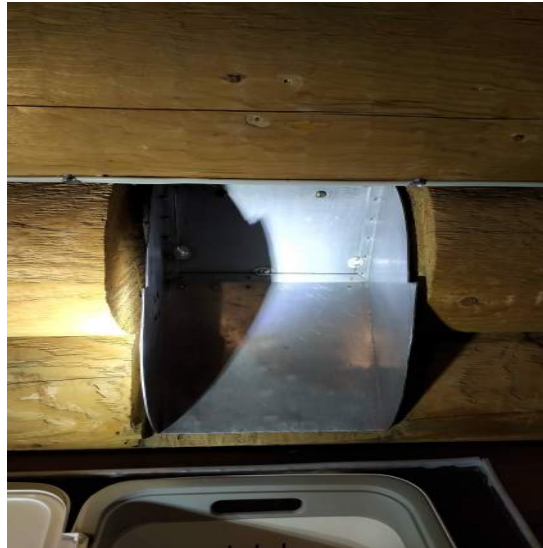
Of minor note, we observed the book drop to be a site fabricated door with no means of air leakage prevention or fire control. Upgrading the interior drop to a steel insulated box, with a door to prevent air leak, and contain any arson attempt is recommended.

Uninsulated Book Drop

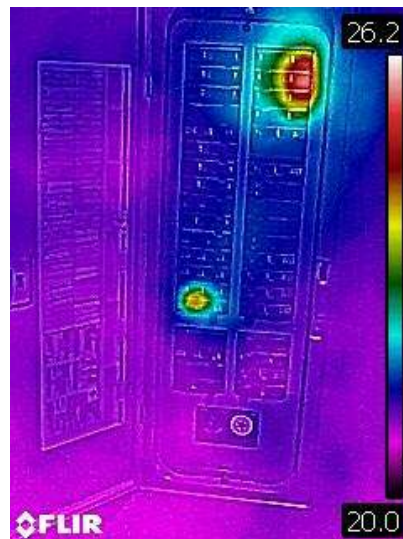
During our field review, we employed a thermal imaging device. Although outside of our scope, the camera detected that circuit breakers were running hot, indicating overload. While this aspect is not part of our retained review parameters, we bring the issue to your attention for further investigation and resolution.

Warm Breakers.
