DISTRICT OF HUDSON'S HOPE

**Lift Station Assessment – Kendrick (Dudley Drive)
and Adam Street Lift Stations | JAN 2022**

DATE: JANUARY 26, 2022

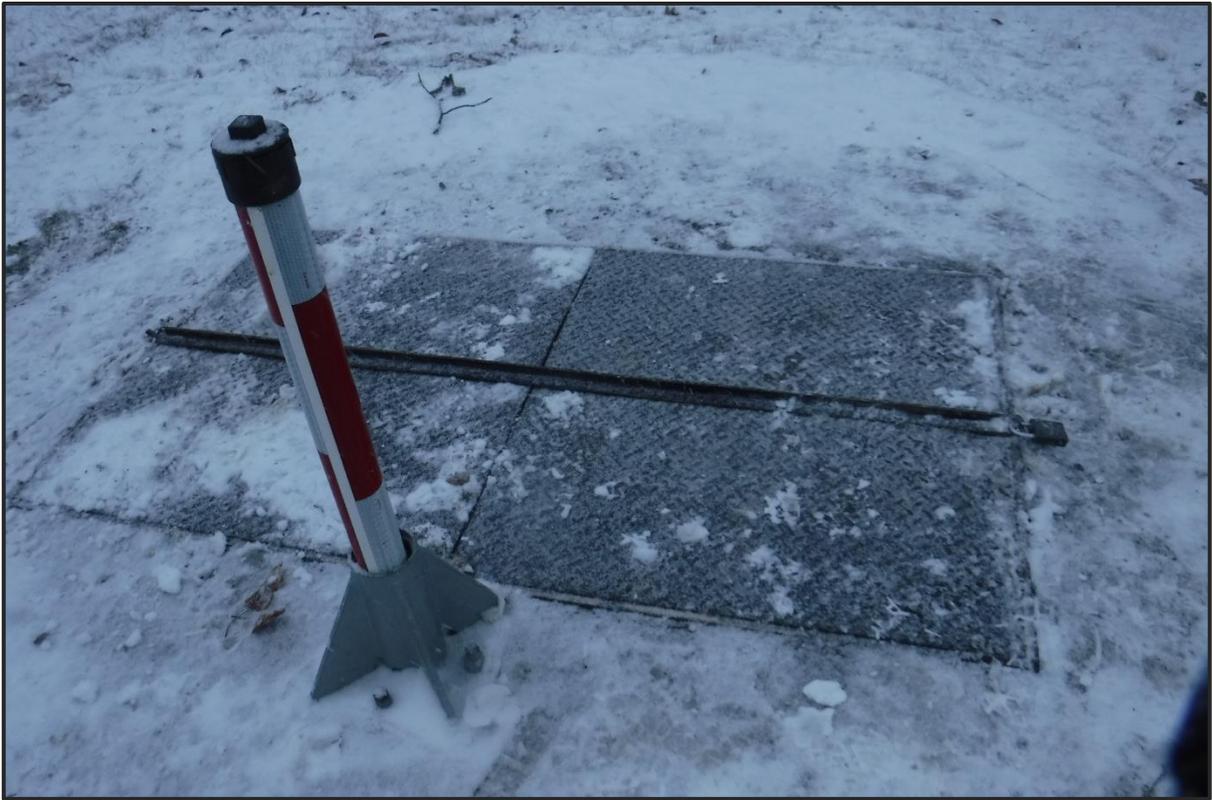
- The steel cover plates do not have handles to aid in removal and are not connected to the frames. Due to the size and weight of these cover plates, it is difficult and unsafe for staff to remove them, a concern that was brought forward by District staff. Reinstalling them creates hazardous pinch. Given the shape of the of the plates, there is also a risk for them to fall into the wet well and to damage piping or equipment below.

Photo 1: Access hatch. Note the lack of fall restraint system and lack of handles on the cover plates.

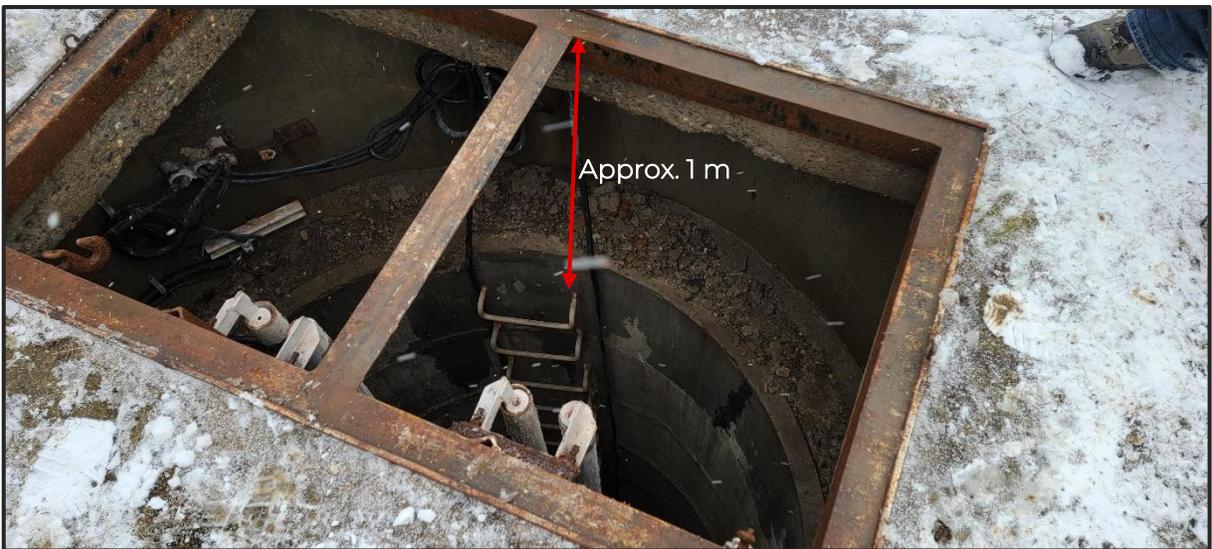
- The first ladder iron is approximately 1 m below the lid which makes it difficult and unsafe to reach when entering the wet well. Based on our understanding this would be in contravention to WorkSafeBC requirements for access to confined spaces.

Photo 2: Vertical drop of approximately 1 m from ground level to first ladder iron.

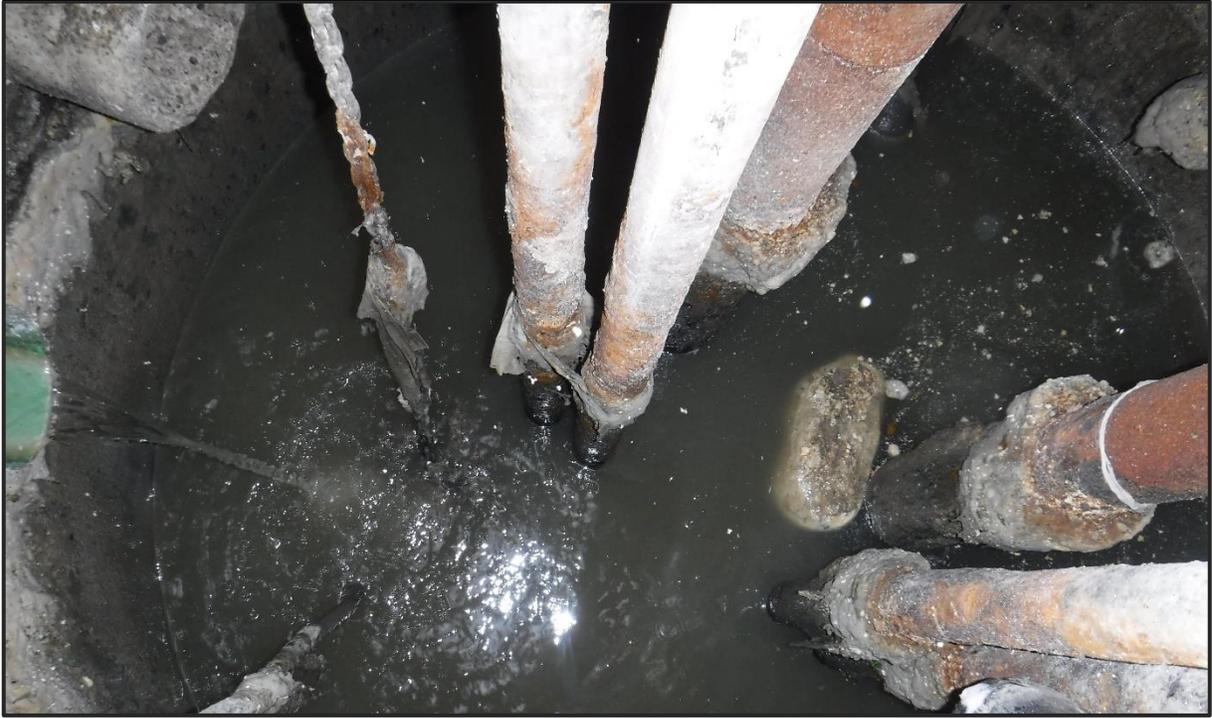
Photo 3: Buildup of deleterious materials (e.g. grease, oils) on walls of well, pipes, and rails. Note corrosion of rails.

- Clean the corrosion off the ladder irons and apply a protective coating to prevent further corrosion.
- Fully pump out the wet well and clean the buildup of grease on the lower walls. Complete a structural inspection of the base at this time as well.

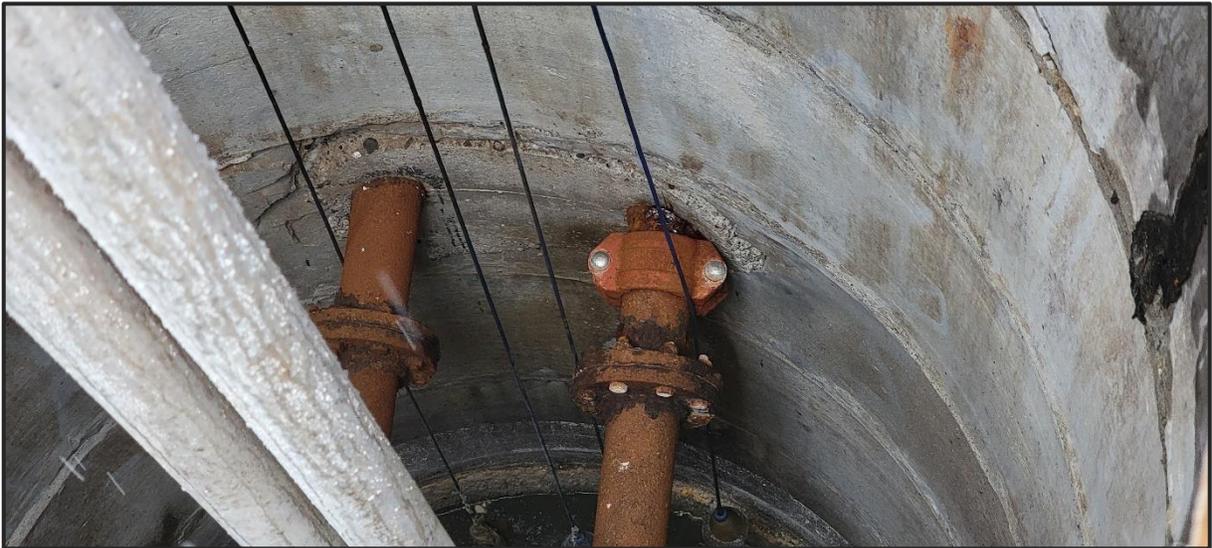
- The wet well piping appears to be beyond its service life. There was previously a leak on the force-main just before the inside wall of the wet well. This was repaired with a steel repair coupler. From discussions with the District's Public Works staff, they suspect that this leak was likely caused by pitting leading to a crack. If there is pitting corrosion to the degree that it is causing pipe failure, it is possible that other piping

- When Urban was on site, heavy surface corrosion was observed on the steel piping downstream of the pumps. The full extent of the corrosion is uncertain, but given the past failure, and corrosion observed, it seems likely that the piping is susceptible to additional failures.

Photo 4: Clamp repair on pipe that previously leaked.

- Complete regular inspection and preventative maintenance.
- Inspect and clean the pumps and other equipment quarterly.
- The wet well piping appears to be beyond its service life. Due to the recent leaks and the heavy corrosion of the piping and check valves within the wet well, these and all other mechanical components should be replaced.²

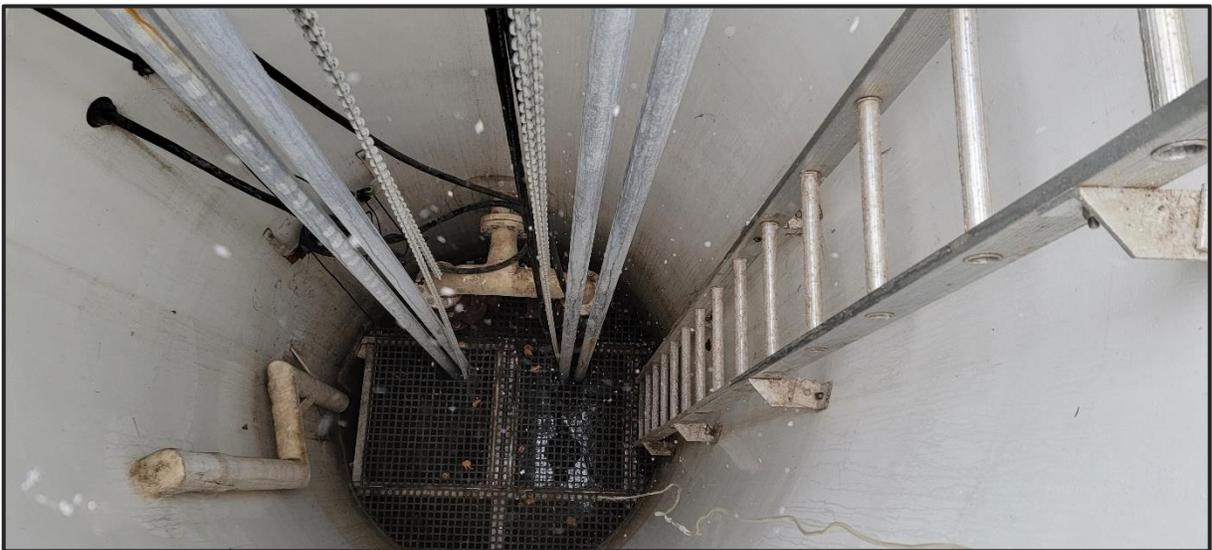
Photo 6: Interior condition of wet well.

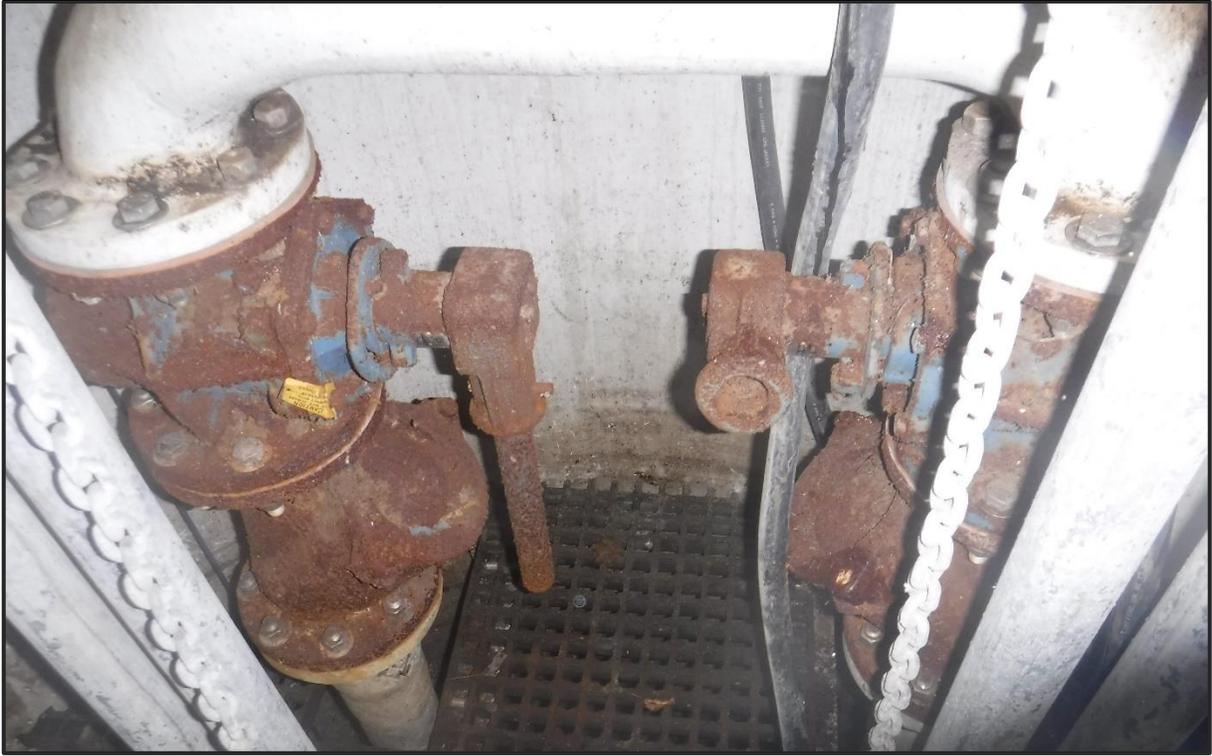
Photo 7: Force-main condition at platform.

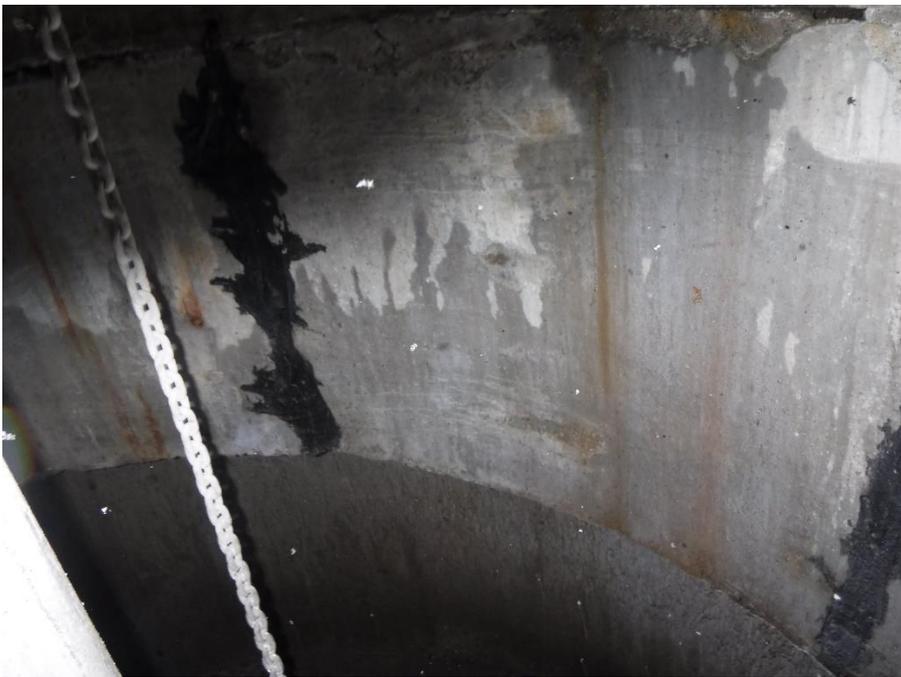
Photo 2: Vertical cracks sealed with bitumen mastic.

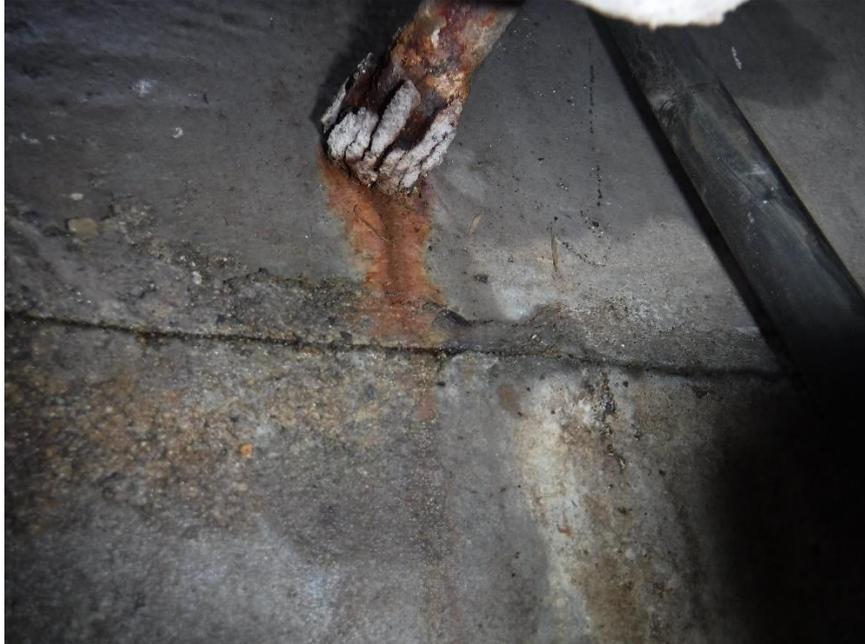
Photo 3: Corroded ladder irons.

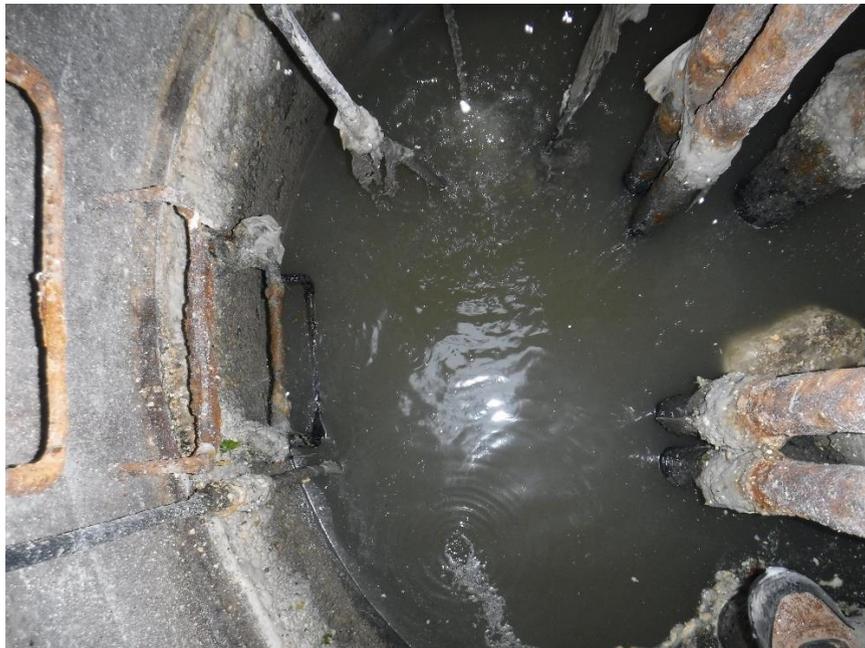
Photo 4: Grease build up around the pipes and ladder irons at the bottom

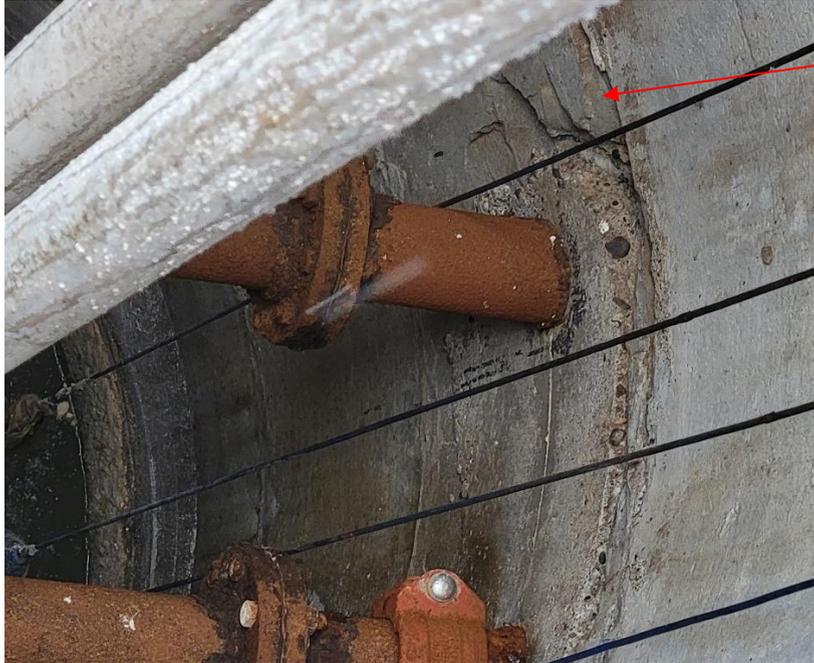
Spalling of concrete

Photo 5: Spalling of concrete around the pipe connection.

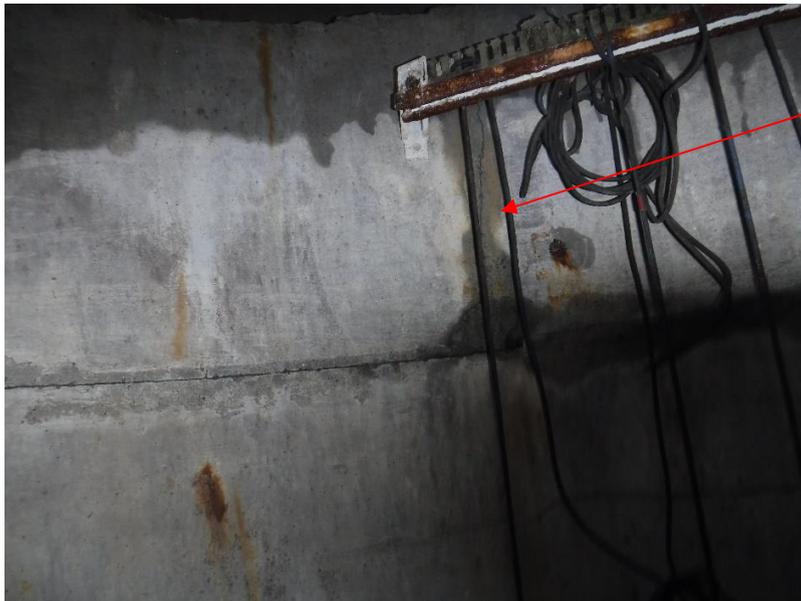
Vertical crack

Photo 6: Vertical crack in the precast wall.
(Moisture around the crack and top of the wet well wall is due to snow precipitation from above)

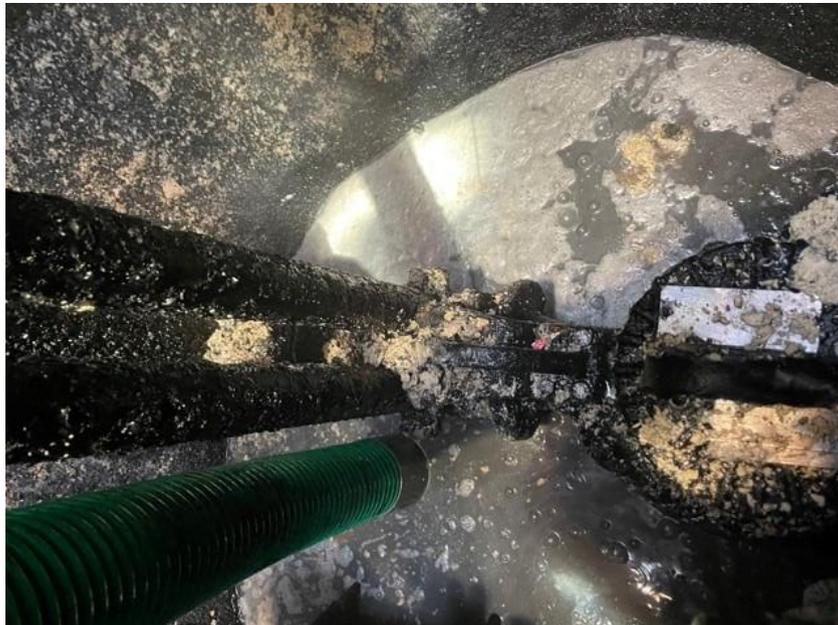
Photo 8: Bottom of the wet well covered with sanitary sewage deposits.

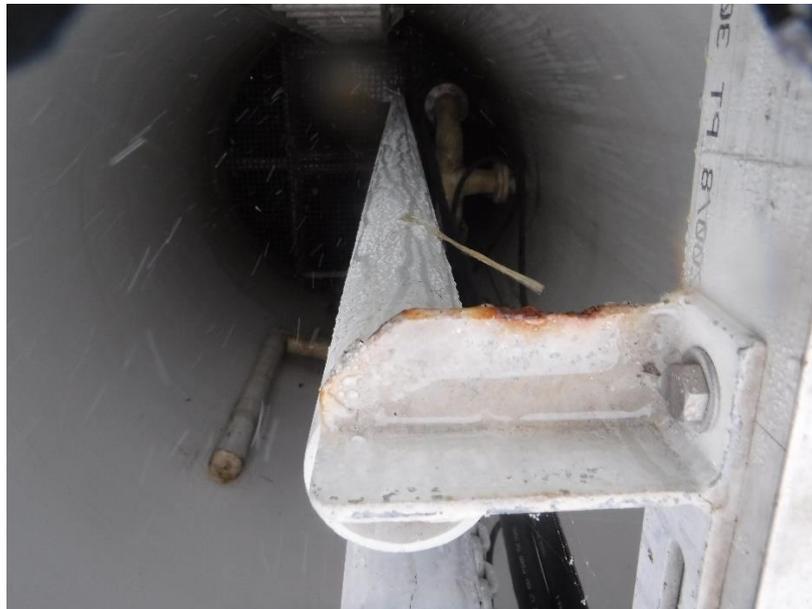
- Minor corrosion was noted on the connections between the ladder and the wet well walls.
- The platform was observed to be in good condition.

Photo 2: Minor rust stain on the ladder.
