HAZARDOUS MATERIALS SURVEY REPORT

Pre-Demolition

Client: District of Hudson's Hope

Project Address: 10310 Kylo Street, Hudson's Hope, BC

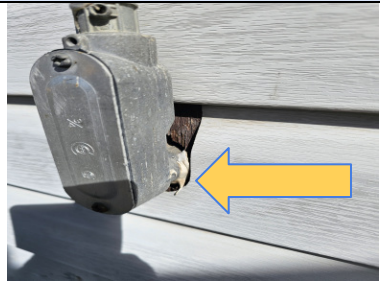
Material	Location	Sample ID	Condition	Friability	Asbestos Content	Photo Ref.
Caulking, White	Exterior Loc. 1	A001	Good	NA	None Detected

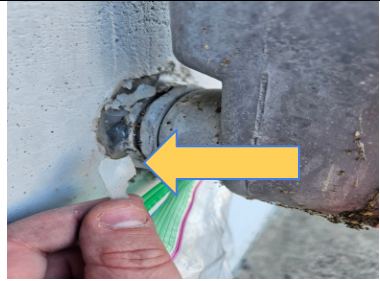
Caulking, Grey	Loc. 1	A002 a-c	Good	NA	None Detected

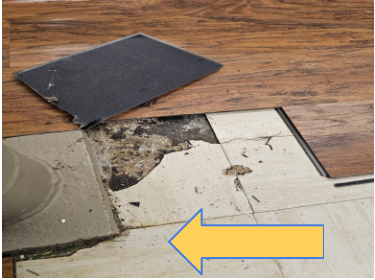
Material	Location	Sample ID	Condition	Friability	Asbestos Content	Photo Ref.
Vinyl Floor Tile	Loc. 2	A007	Good	NA	None Detected

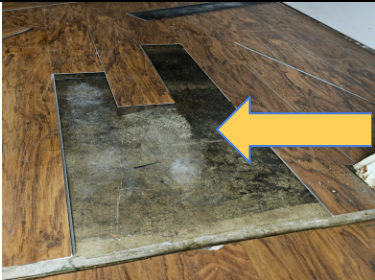
Mastic	Loc. 6	A008	Fair	NA	None Detected

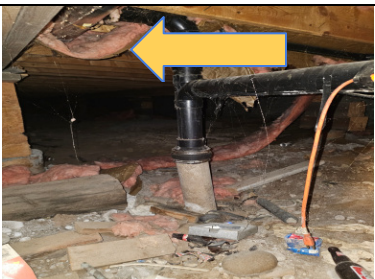
Tar Paper	Loc. 6	A009	Good	NA	None Detected

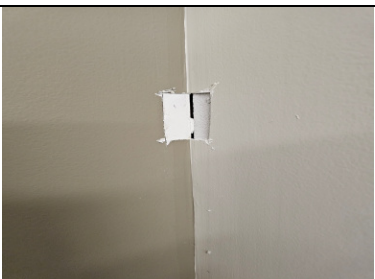
Drywall Tape Compound	Loc. 2, 5, 8, 9, 10	A010 a-i	Good	None-friable	1% Chrysotile - Approximately 2000 square feet

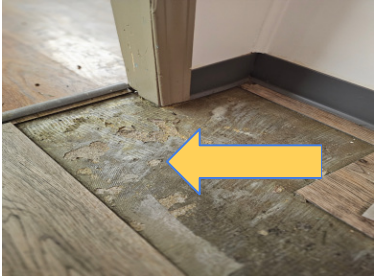
Material	Location	Sample ID	Condition	Friability	Asbestos Content	Photo Ref.
Mastic	Loc. 10	A011	Good	NA	None Detected

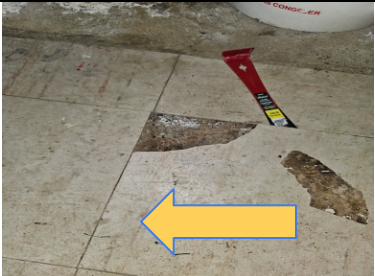
Vinyl Floor Tile, grey with red	Loc. 9	A012	Good	Non-Friable	1% Chrysotile - Approximately 150 square feet

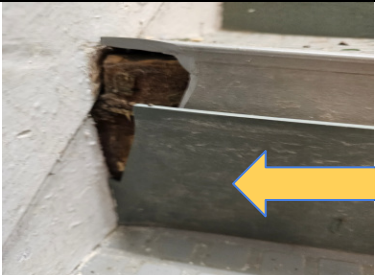
Firestop	Loc. 5	A013	Good	NA	None Detected	Photo not available
Vinyl Flooring - Riser	Loc. 10	A014	Good	NA	None Detected

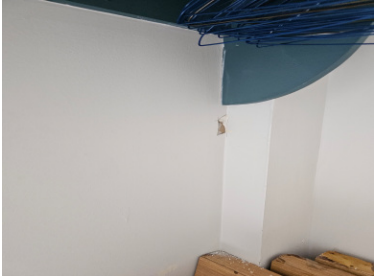
Material	Location	Sample ID	Condition	Friability	Asbestos Content	Photo Ref.
Drywall Tape Compound	Loc. 13, 14	A019 a-e	Good	NA	None Detected

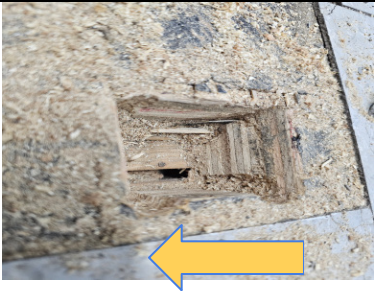
Vinyl Floor Tile - Dark Grey	Loc. 11	A020	Good	NA	None Detected

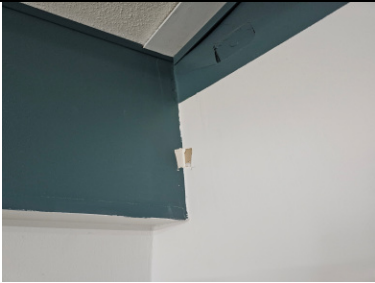
Drywall Tape Compound	Loc. 11, 16	A021 a-e	Good	NA	None Detected

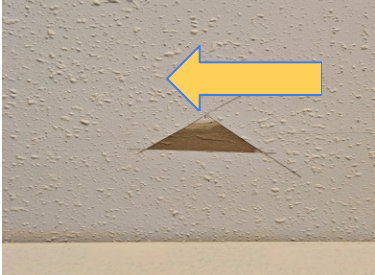
Texture	Loc. 16	A022 a-c	Good	NA	None Detected

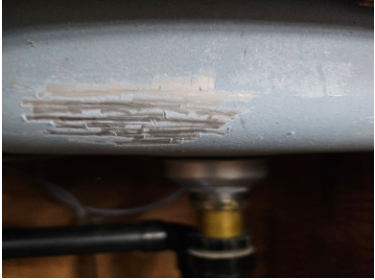
Material	Location	Sample ID	Condition	Friability	Asbestos Content	Photo Ref.
Sink Mastic	Loc. 16	A023	Good	NA	None Detected

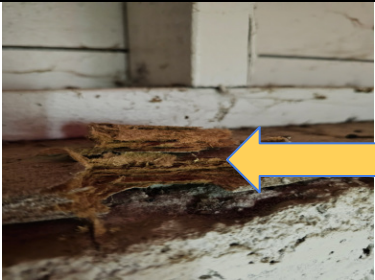
Fiber Board	Basement Stairwell	NA*	Fair	NA	*Cellulose press board

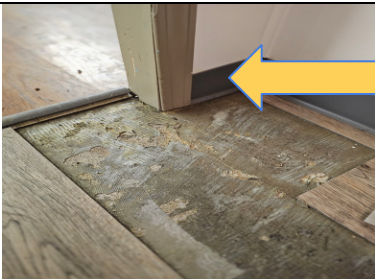
Vinyl Cove base	Through out building	NA*	Good	NA	Rubber cove

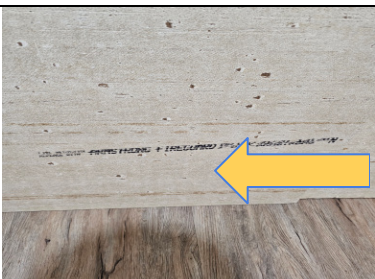
2x4 Ceiling Tiles	Loc. 3, 5	NA*	Good	NA	Date stamped

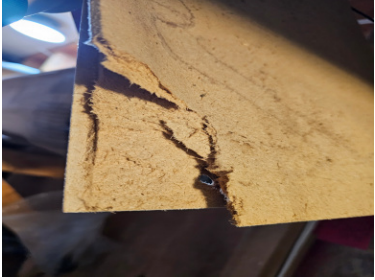
Material	Location	Sample ID	Condition	Friability	Asbestos Content	Photo Ref.
1x1 Ceiling Tile (Stapled)	Loc. 3	NA*	Good	NA	*Stapled, no mastic Cellulose

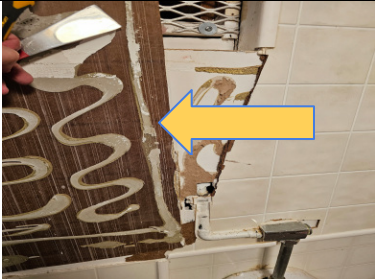
Faux ceramic tile wall board	Loc. 5	NA*	Good	NA	Cellulose press paneling

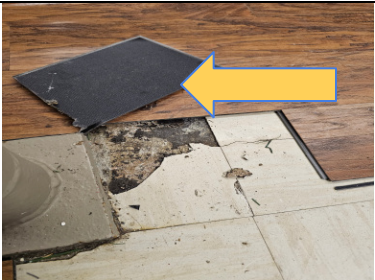
Vinyl Plank Flooring	Loc. 2	NA*	Good	NA	New construction Vinyl Plank

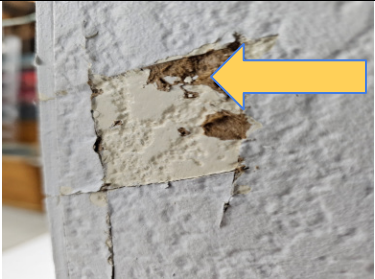
Textured Wallboard	Loc. 11	NA*	Good	NA	Textured cellulose press board**

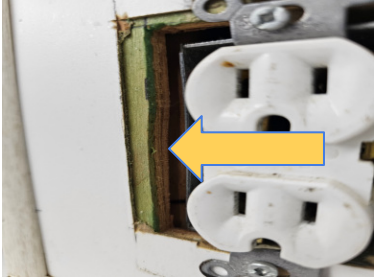
Material	Location	Sample ID	Condition	Friability	Asbestos Content	Photo Ref.
Vinyl Veneer on wood walls	Kitchen, Loc. 15	NA*	Good	NA	Vinyl veneer on wood press board

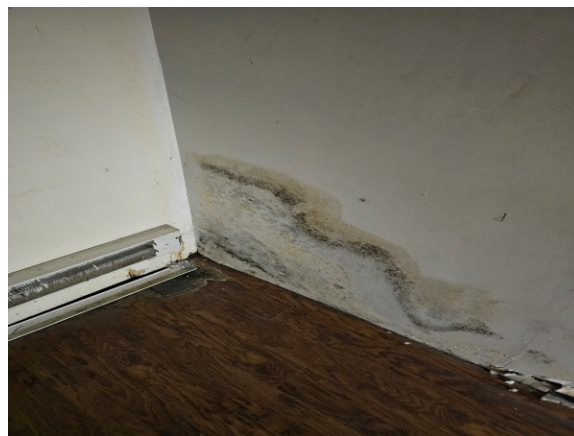
Approximately 20 square feet of mould growth was identified in the basement storage (Loc. 6).
