SR9 Water Conservation Plan (Update 2019)

Water Conservation Plan

**The District Of Hudson's Hope
2019 Water Leakage Detection Survey
Final Report**

District Of Hudson's Hope **2019 Leak Detection Final Report**

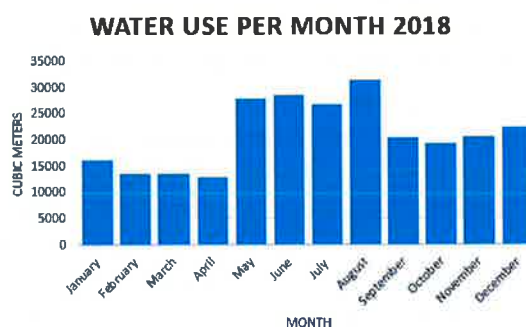
Figure 3 Water Use Per Month 2018

Water conservation is a prevalent topic with more and more municipalities providing incentives and running initiatives to reduce and reuse water. In 2010, when the last water conservation plan was created, water use was measured at 640 litres per person per day², this is considered high. Over the last 10 years the national average water usage is on the constant decline. From 2011 to 2017 there was a 13% reduction in total water use nationally. The current water usage within the District is estimated for 2018 to be 649 litres per person per day³. This represents an increase of roughly 1% over nine years. This is very similar water usage to the last water conservation plan but still lags the national average. It also shows that the District is trending in the opposite direction as the national average. Therefore, a greater focus is needed to reduce the District's usage and there exist reduction strategies that can help make sizable decreases.

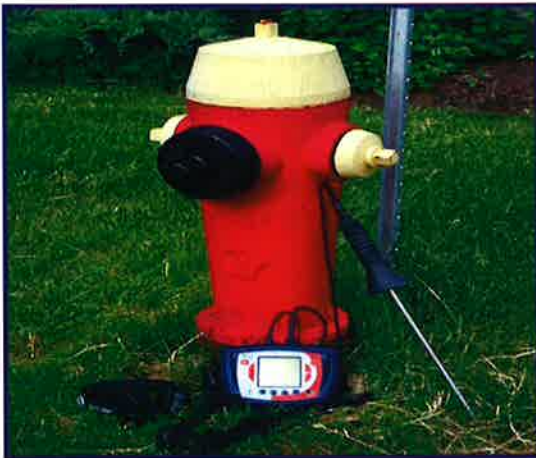
Fig 1: X-Mic Listening System

A proven method for leak detection involves the use of a sensitive X-Mic® acoustic listening device (Fig 1), and a trained operator. Pressurized water forcing its way through a crack or joint makes a distinct sound that can be heard on pipes, valves, hydrants or services. Potential leak sites can be identified by this method and further localized by Correlation Testing.

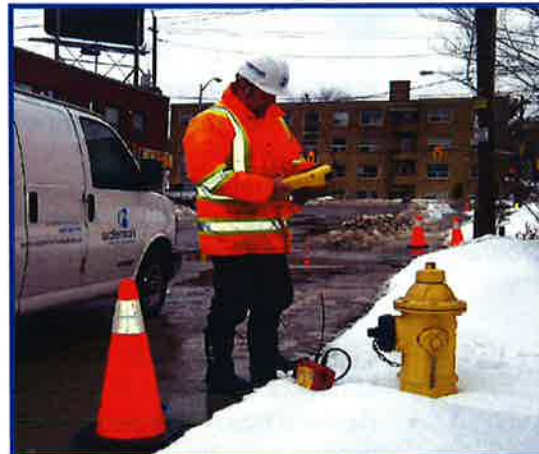
Fig 2: Leak Noise Correlator

These tests are carried out with modern computer-based instruments, called ‘Leak Noise Correlators’ (Fig 2) that have a simple field setup and work by measuring leak signals (sound or vibration) at two points that bracket a suspected leak. A sensor is attached magnetically to a valve, hydrant or pipe on either side of the suspected leak location. The position of the leak is then determined electronically based on the time shift between the leak signals and calculated using a cross-correlation method.

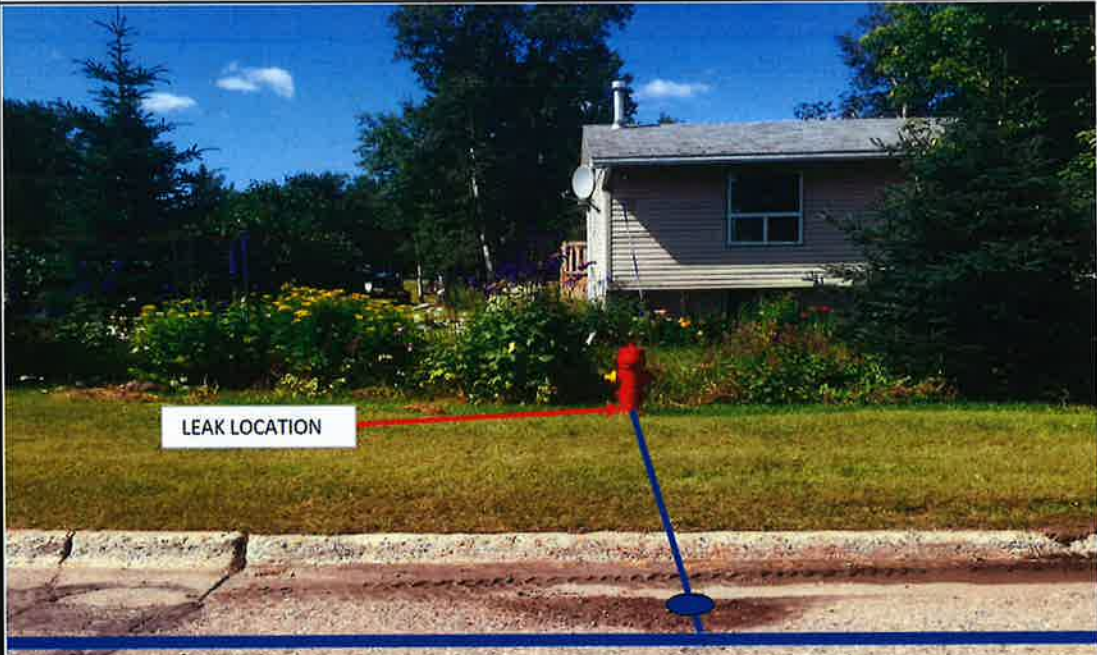
Comments: LEAK ON HYDRANT AT KYLLO/ROBISON. GOOD LEAK NOISE ON HYDRANT. NONE ON OTHER FITTINGS IN VICINITY. ISOLATION OF HYDRANT AT SECONDARY VALVE STOPS LEAK NOISE. SUGGEST FLUSH AND HYDRANT MAINTENANCE.					
Notes: When site detailed information is not available, the information is based on field locating and represents best knowledge of the approximate location.					
Technician	LEE STANSFIELD	Signature

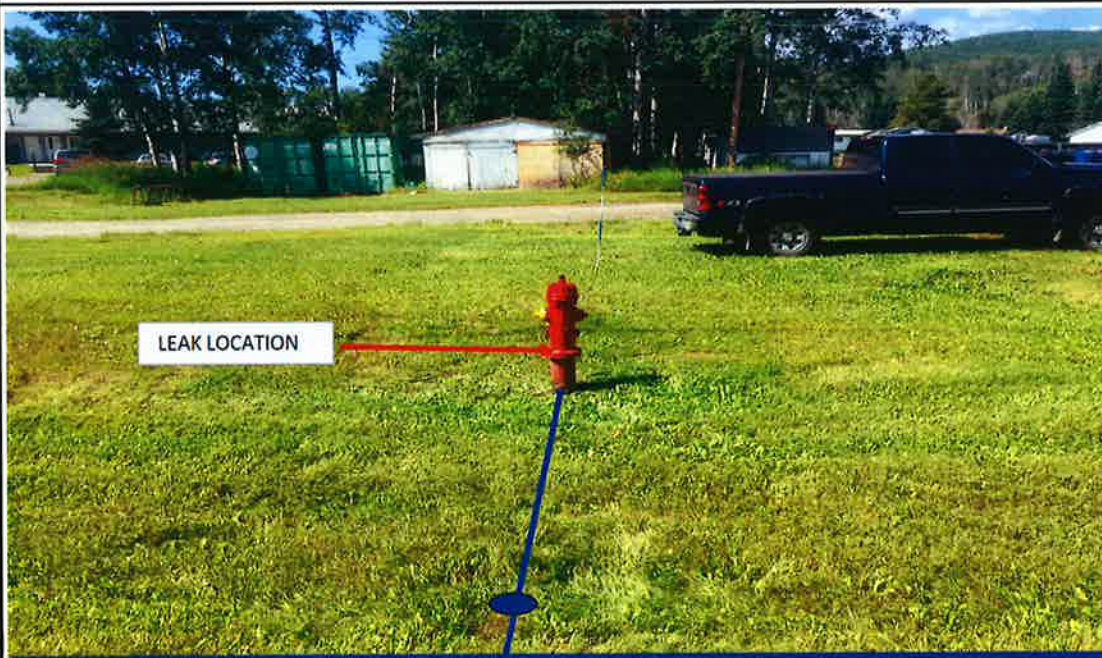
Project #		Date	25/07/2019	Time	12:00:00
Material	ASBESTOS CEMENT/TRANSITE	Site Address			
Diameter	150MM	MacDOUGALL ST/SILVER WILLOW CT			
Priority	B	Intersection			
Asset ID		MacDOUGALL ST/SILVER WILLOW CT			
Leak Type	HYDRANT

Comments: LEAK ON HYDRANT ON MacDOUGALL O/S GROCERY STORE. GOOD LEAK NOISE ON HYDRANT. NONE ON OTHER FITTINGS IN VICINITY. ISOLATION OF HYDRANT AT SECONDARY VALVE STOPS LEAK. SUGGEST HYDRANT MAINTENANCE.
