# 2025 Community Water System Annual Report

NORTHERN HEALTH OPERATING PERMIT NO. 2384

District of Hudson's Hope  
5-4-2026

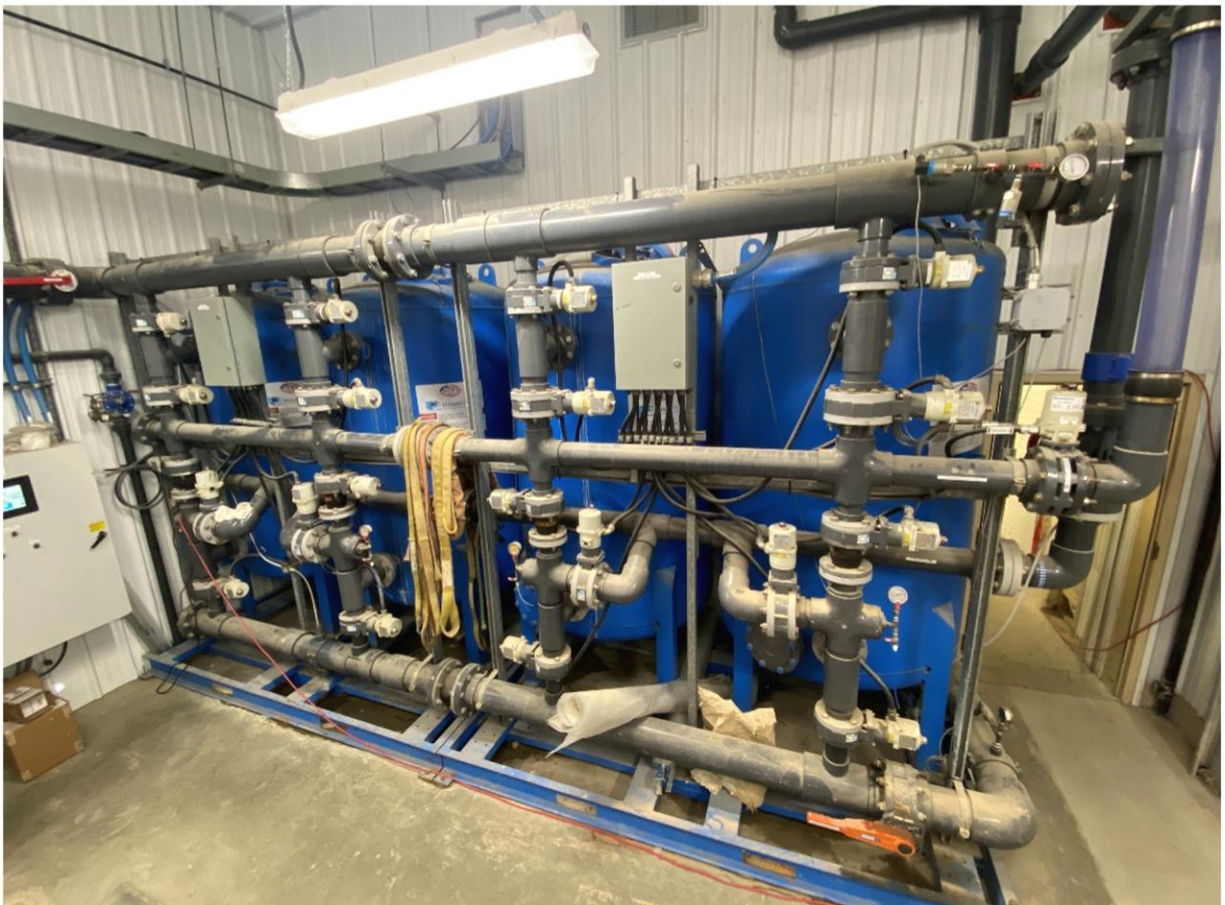
Media filtration is achieved by 4 filtration vessels supplied by Bi-Pure Water running in parallel as seen below, Figure 4: Media Filters. The media inside these is comprised of green sand which, while reducing suspended matter, also helps reduce the elevated iron and manganese content found naturally in the peace river as seen in Table 9: Total Metals Results. This is where much of the remaining suspended material is filtered from the water stream, post clarification.

*Figure 4: Media Filters*

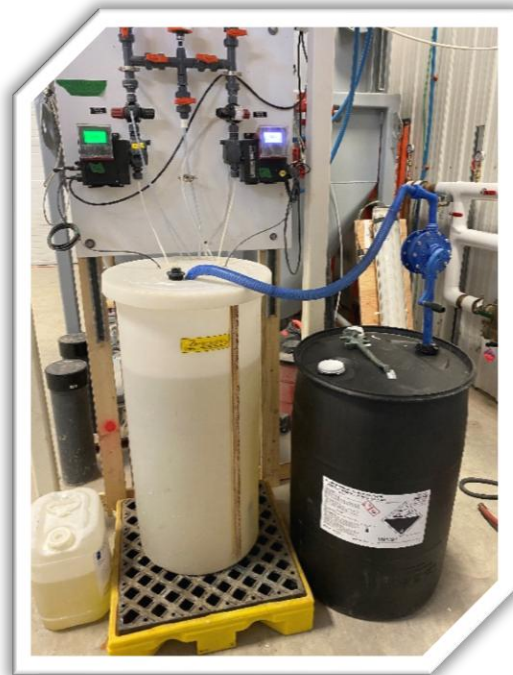
Sodium hypochlorite is dosed, by one of two pumps operating in a duty/standby configuration, into the water line after the media filters. A 12% concentration trade solution of sodium hypochlorite supplied by Brenntag is used as the primary disinfection solution.

Dosing is flow based with a value of 1.40mg/L being maintained for the exiting distribution water. This allows for residual protection throughout the water network maintaining resistance against disease causing microbes that could grow and cause illness without it. A CL17 automatic chlorine analyser relays the dose rate to the feed pumps every 3 minutes to sustain this protection throughout our network. Should the detected chlorine in the distribution system rise or fall below the designated tolerances the WTP will shut down to prevent the distribution of potentially non potable water.

Figure 5: Chlorine Dosing

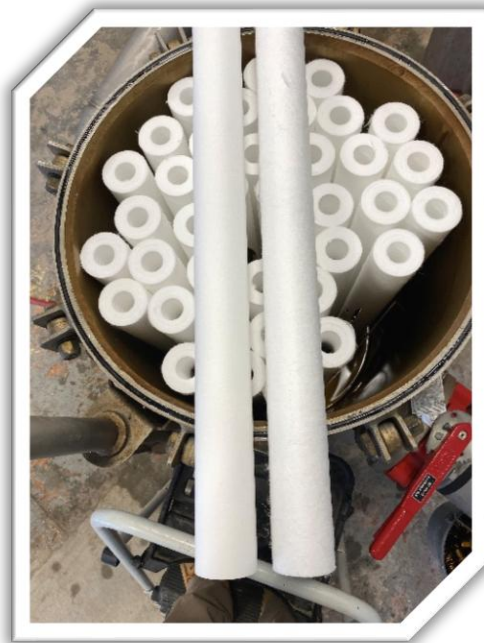
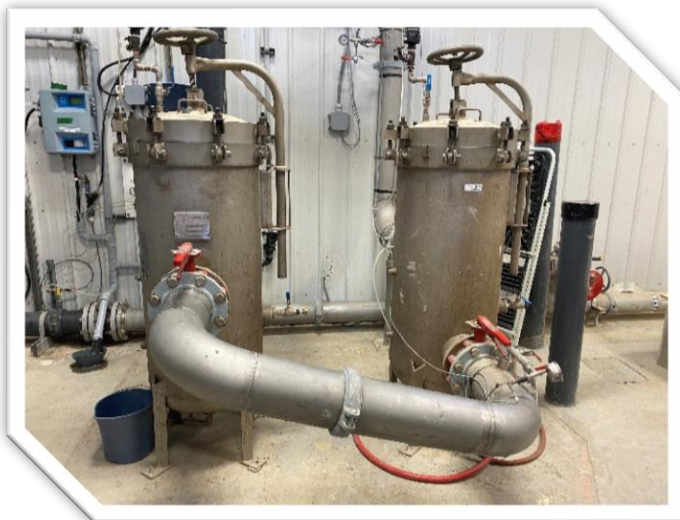
Two cartridge filters running in series provide a final filtering of the water to remove excess turbidity and color. While cartridge filtration provides a small reduction in water turbidity it is mainly used as an extra precaution to produce clearer water. The 1-micron and 3-micron filters currently used in these steel pots (fig 7) produce finished water that won't stain appliances over time and is what's known as an aesthetic objective (AO) with little bearing on turbidity reduction or potability. These units can also be used for redundancy in the event of a failure in the main filtration system by adapting the filter type. Figure 6 shows a typical biweekly filter changeover in cartridge filter 1 with 40, 3-micron filters. Figure 7 shows both cartridge filters sealed, in operation.

Figure 6: Cartridge Filter Changeover

Figure 6: Cartridge Filters #2 & #1

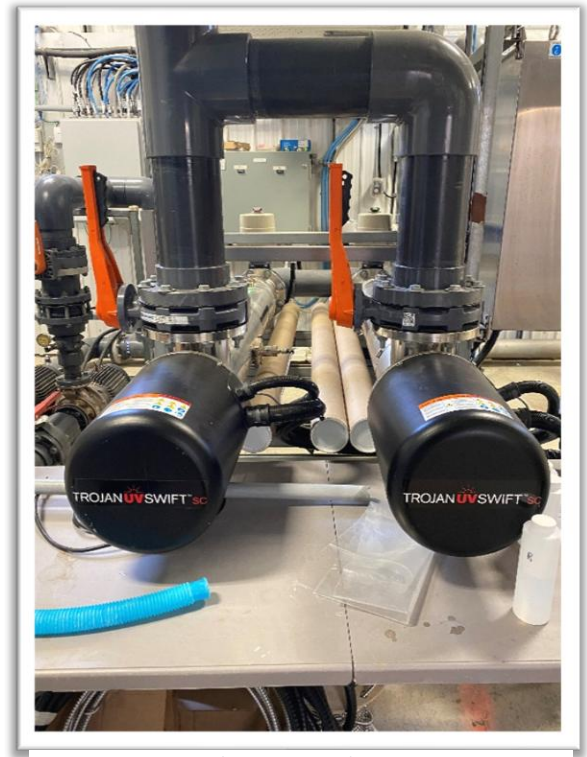
Secondary disinfection is achieved by employing 2 TrojanUVSwift SC Ultraviolet Treatment chambers outputting UV-C light and running in a duty standby configuration. This process serves to inactivate any pathogens left after primary disinfection. UV disinfection prevents the replication of pathogens by disrupting their DNA and RNA. This method is effective at neutralising minute viral pathogens such as Giardia, Cryptosporidium, E. coli and Salmonella which could resist the action of our primary disinfection strategy (chlorine). Operators can observe the clarity and quality of the produced water through the systems control panel and make adjustments accordingly.

Figure 7: UV Filters

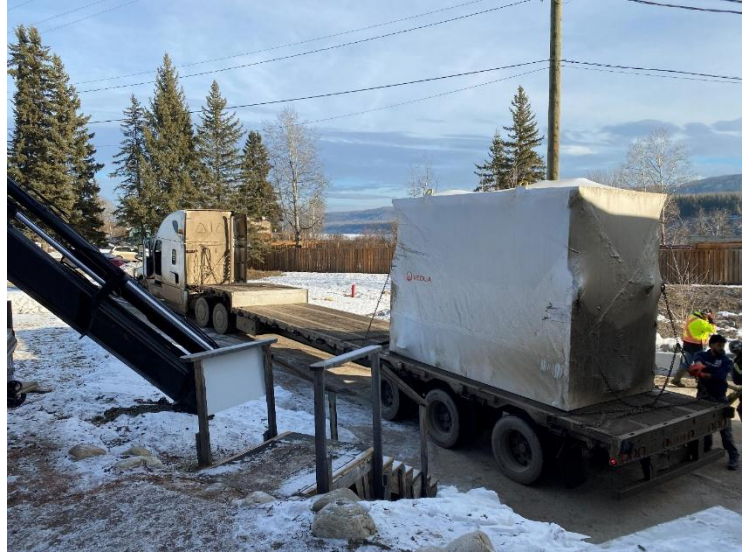
Figure 9: Clarifier Delivery

Shipment of new clarifier, polymer skid and control equipment received from Veolia as shown above, Figure 10: Clarifier Delivery.

A source water that routinely has less than 1.0 Nephelometric Turbidity Units (NTU) is considered a great starting point and as the annual testing shows *Table 8: Routine Water Testing Results*, a result of <0.2 NTU for raw (intake) water is exceptional. To highlight the variability however, the current turbidity as of writing (April 25) sits at over 6.0 NTU, which poses a challenge to adapt to and treat. This annual change necessitates the employ of a capable clarification unit as seen secured in 2025; Figure 10: Clarifier Delivery.

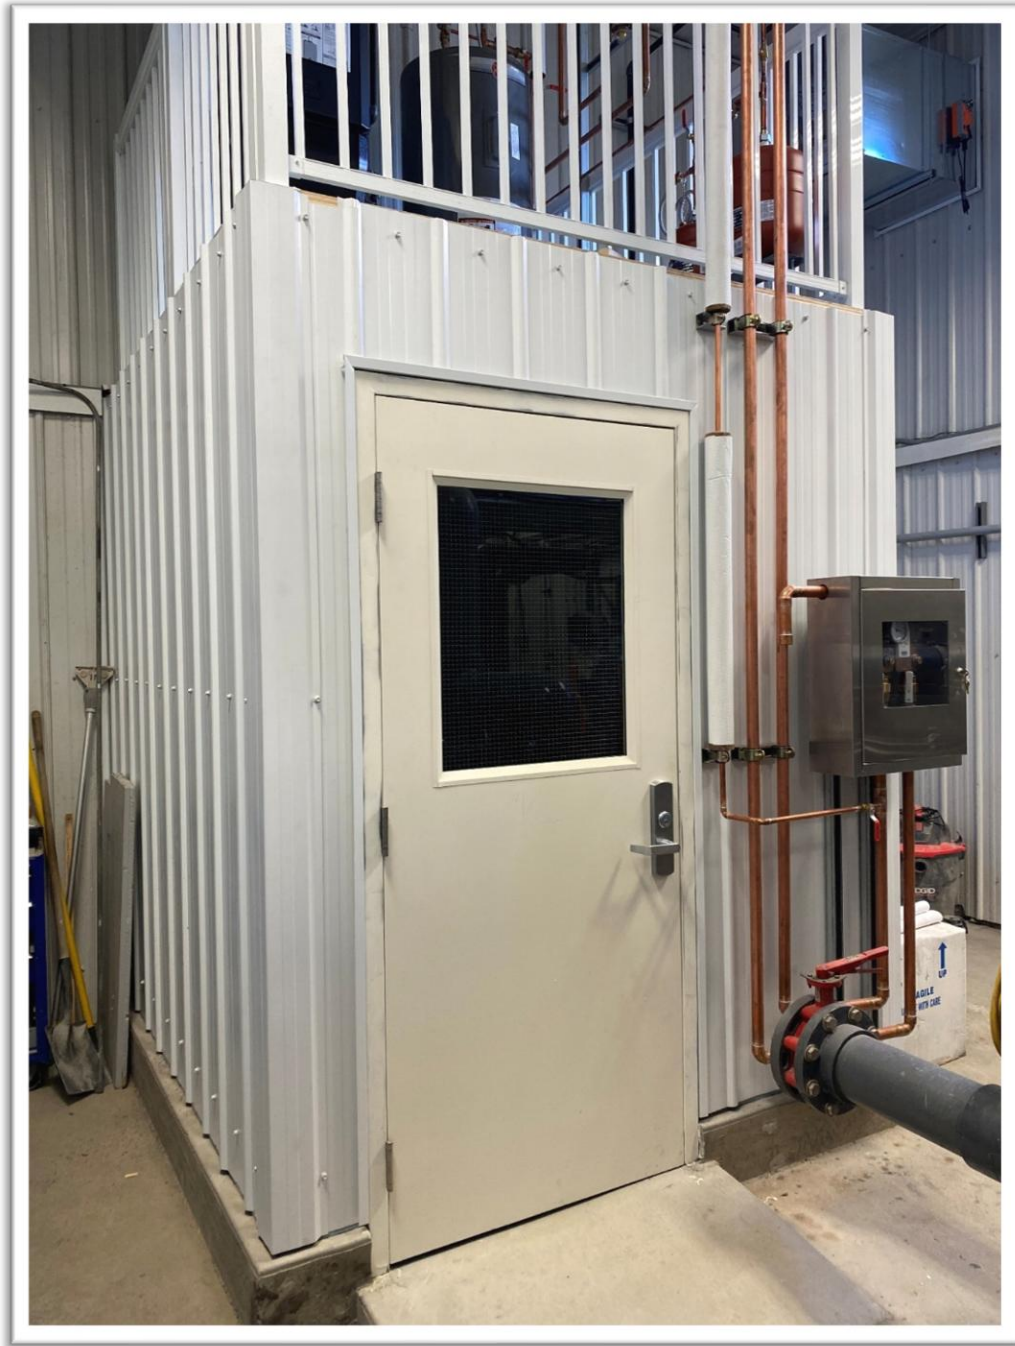
*Figure 11: New Chlorine Room*

rated chlorine room constructed by CWM after removal of pre-existing, decommissioned stainless-steel tank obstruction.

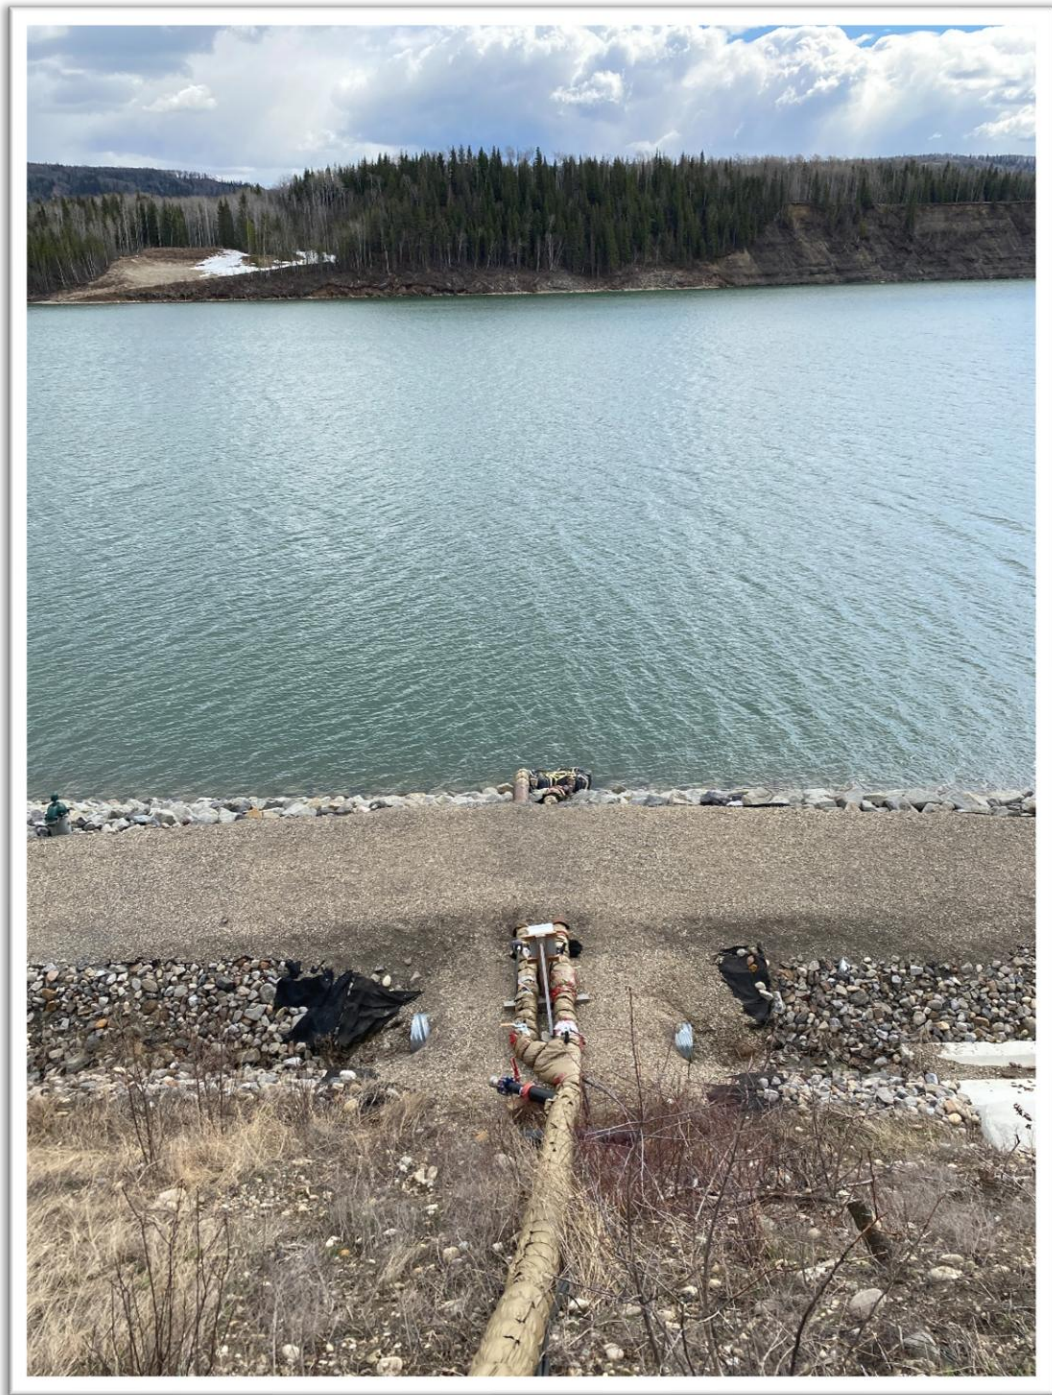
*Figure 17: Raw Intake Pipes*
